**MAJOR REPAIR AND ALTERATION**  
(Airframe, Powerplant, Propeller, or Appliance)

1. Aircraft	Nationality and Registration Mark USA N9456P	Serial No. 24-4974
	Make Piper	Model PA-24-260
2. Owner	Name (As shown on registration certificate) N9456P LLC	Address (As shown on registration certificate) Address 5901 N. Grand Canyon Dr. City Las Vegas State NV Zip 89149 Country USA

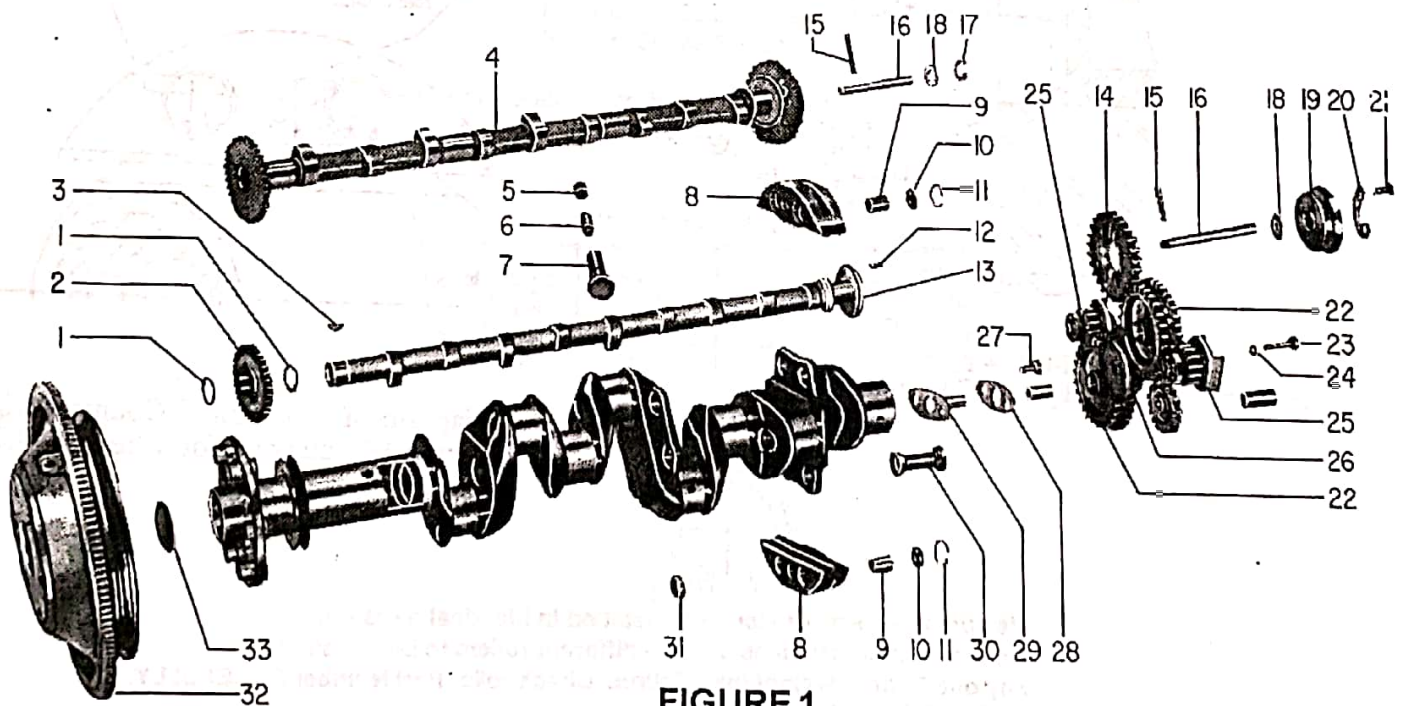
FIGURE 1

Use Figure 1 (Typical Crankshaft and Related Parts) as shown below to aid in Counterweight Removal and Installation.

1. Remove the two (2) Lycoming Counterweights, P/N 71904, and (2) Rollers, P/N 70416 and (2) P/N 72022, merely by removing the retaining rings, CPR-2 Figure 1, Ref. 11, after which the Washers, Ref. 10, Rollers, Ref. 9, and Counterweights, Ref. 8, may be detached from the Crankshaft Lug.
2. After removing 71904 Counterweights and prior to installing 72801 Counterweights, dimensionally check bushings in Crankshaft Counterweight Cheeks. Any bushings not meeting New Lycoming specifications must be replaced per latest version of Lycoming Service Instruction 1142.

NOTE: All reference numbers refer to Figure 1, P.2 of CPR-2.

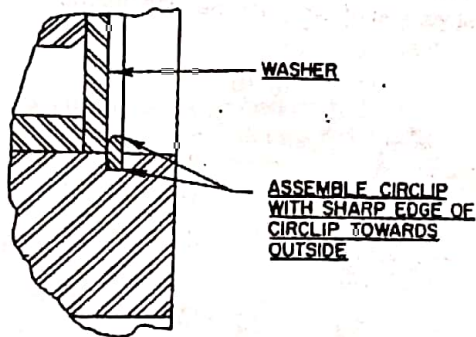
Figure 2  
Assembly of Circlips in Counterweight

CIRCLIP P/N	"A" DIM	"B" DIM	GAGE	APPLICATION
71906	.892	.198	64892-2	ALL C/W'S
LW-14820	.892	.198	64892-2	ALL C/W'S
77005	1.132	.245	64892-3	LARGE C/W ON 1800-541 ONLY

- Per Lycoming Service Instruction 1012 Rev.F, Install New P/N 71907 Washers, Ref.10, and New P/N LW11750 (71906) Retaining Rings, Ref. 11, on one side of New Style Rebuilt or New Counterweight Assembly, P/N 72801, Ref.8, and place the Counterweight on its proper lug on the Crankshaft per Figure 2, Service Instruction 1012 Rev. F. Insert (2) New Rollers, P/N 72797, Ref.9, and secure assembly by installing New P/N 71907 Washers and P/N LW11750 (71906) Circlips on the other side of the Counterweight. All the Bushings, P/N 71903, in the Counterweights must be New and Finished per Lycoming Service Instruction 1143. Circlips are inserted with sharp edge outward ( see CPR-2 Figure 2). Two gages will check all circlips in any Avco Lycoming Counterweight. See Table on Figure 3, of CPR-2.

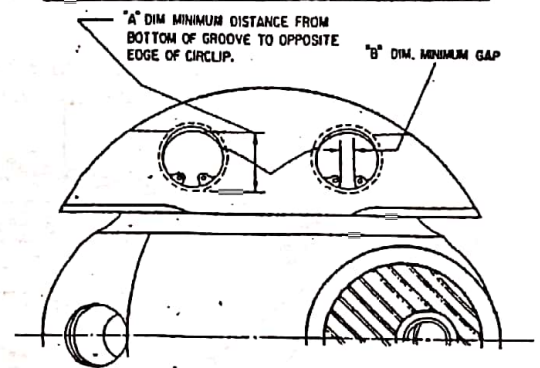
Figure 3  
Diagram of Assembled Counterweight Showing Dimensions for Checking Circlip

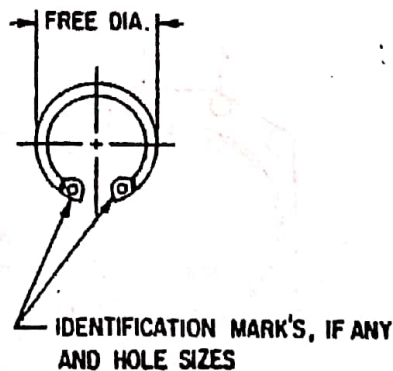
FREE DIA.	HOLE SIZE	STAMPED MARK	P/N
1.056	.072/.060	93	71906
1.056	.093/.076	N/A	LW-14820
1.344	.090/.076	N/A	77005

**Figure 4**  
**Circlip Identification**

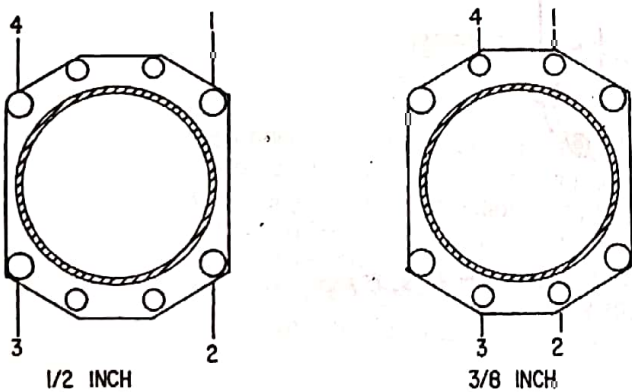
Figure 5 Sequence of Tightening  
Cylinder Base Nuts

4. Check 3/8 inch nuts for tightness on the remaining cylinder base studs by bringing torque up to 300 in. lb (25ft.lb). Sequence is optional.
5. After all cylinder base nuts have been tightened, remove any nicks in cylinder fins by de-burring or filing.

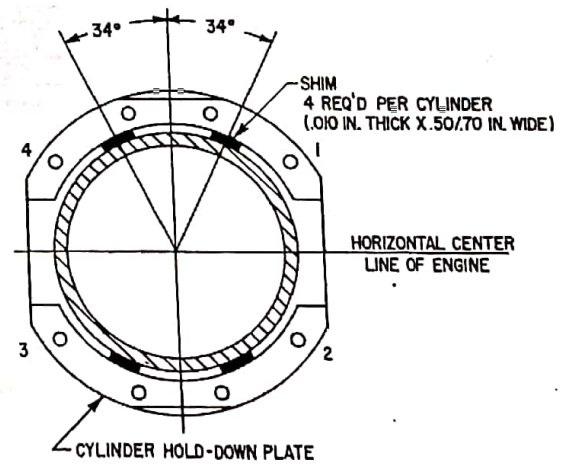
INSTRUCTIONS—ON ENGINES USING CYLINDER HOLD-DOWN PLATES, DURING INITIAL TIGHTENING, USE TWO SHIMS BETWEEN EACH PLATE AND THE BARREL, LOCATED AS SHOWN. REMOVE SHIMS BEFORE FINAL TIGHTENING.

Figure 6 Location of Shims Between  
Cylinder Barrel and Hold-Down Plates

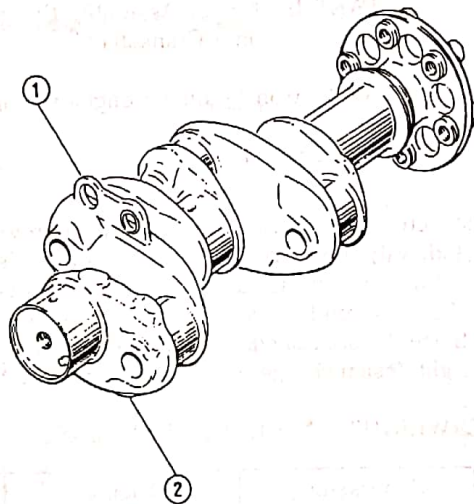
Figure 1.  
Counterweights and Rollers - Group 1

Group	Counterweights P/N	Qty. No.	Roller P/N	Qty. No.	Location
<b>Group 1 (4 Cyl. Direct Drive Engines)</b>					<b>Figure 1</b>
0-360-A1F6, -A1F6D, -A1G6, -A1G6D, -E1A6D, -F1A6, -G1A6; LO-360-A1G6D, -E1A6D; IO-360- A1B6, -A1B6D, -A1D6, -A1D6D, -A3B6D, -A3D6D, -B2F6, -C1C6, -C1D6, -C1E6, -J1A5D; AEIO-360-A1B6, -B1G6; LIO-360-C1E6; TO-360- C1A6D, -E1A6D, -F1A6D; LTO-360-E1A6D; TIO- 360-A3B6, -C1A6D.	LW-19227 LW-19227	1 1	LW-10977 LW-10945	2 2	Either Position Either Position

Part I separates applicable engines into groups that utilize the same basic crankshaft design with the same counterweight and roller configuration. The location column in the table that accompanies each group references the group to a numbered figure which is an illustration that is typical of the crankshaft installed in the engines listed with the group. Each counterweight lobe position is numbered on the illustration and the location column in the table assigns each counterweight and roller combination to one or more of these numbered positions.

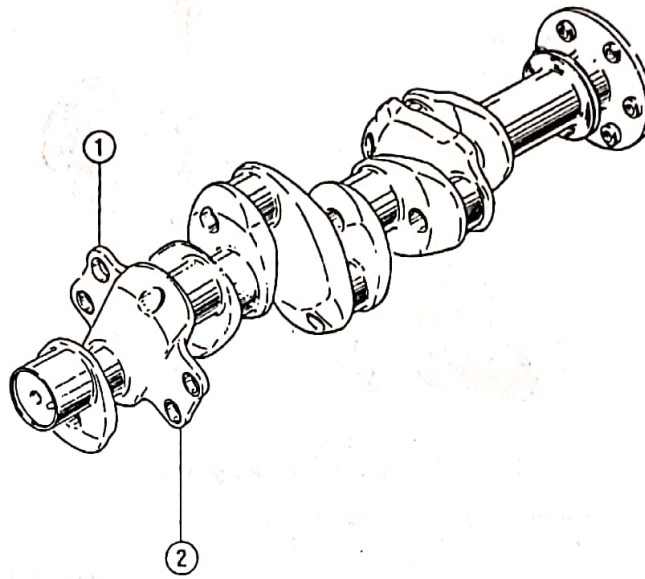
Figure 2.  
Counterweights and Rollers - Group 2, 3, 4, 5, 6, 7

Group	Counterweights P/N	Qty. No.	Roller P/N	Qty. No.	Location
<b>Group 2 (6 Cyl. Direct Drive Engines)</b> 0-540-A1D, -A2B.	LW-19225	2	70416	4	Figure 2 Position 1, 2
<b>Group 3 (6 Cyl. Direct Drive Engines)</b> 0-540-A1A, -A1A5, -A1B5, -A1C5, -A1D5, -A3D5, -B1A5, -B1B5, -B2B5, -B2C5, -F1A5, -F1B5, -G1A5, -G2A5, -H1B5D, -H2A5, -H2B5D; IO-540-C1B5, -C1C5.	LW-19225 LW-19225	1 1	70416 72022	2 2	Figure 2 Either Position Either Position
<b>Group 4 (6 Cyl. Direct Drive Engines)</b> 0-540-A4D5, -B4B5, -E4A5, -E4B5, -E4C5, -J1A5D; IO-540-A1A5, -B1A5, -B1B5, -B1C5, -C1B5, -C4B5, -C4C5, -C4D5D, -D4A5, -E1A5, -E1B5, -G1A5, -G1B5, -G1C5, -G1D5, -G1E5, -G1F5, -J4A5, -P1A5, -T4A5D, -T4B5D, -T4C5D, -W1A5D; AEIO-540-D4A5, -D4B5, -L1B5D; TIO- 540-C1A, -E1A, -G1A, -H1A, -AA1A5, -AB1AD.	LW-19227 LW-19227	1 1	72965 72797	2 2	Figure 2 Either Position Either Position
<b>Group 5 (6 Cyl. Direct Drive Engines)</b> IO-540-K1A5, -K1A5D, -K1B5, -K1C5, -K1D5, -K1E5, K1E5D, -K1F5, -K1F5D, -K1G5, -K1G5D, -K1H5, -K1J5, -K1J5D, -K1K5, -L1A5, -L1A5D, -L1B5D, -L1C5, -M1A5, -M1A5D, -M1B5D, -M2A5D, -N1A5, -R1A5, -R1A5D, -S1A5, -U1B5D, -AA1A5; AEIO-540-L1B5D; HIO-540-A1A; TIO-540-A1A, -A1B, -A2A, -A2B, -A2C, -F2BD, -J2B, -J2BD, -N2BD, -R2AD, -S1AD, -T2AD, -U2A, -V2AD, -W2A; LTIO-540- F2BD, -J2B, -J2BD, -N2BD, -U2A, -V2AD, -W2A.	LW-19210 LW-19210	1 1	73648 76788	2 2	Figure 2 Either Position Either Position

<b>Group 6 (6 Cyl. Direct Drive Engines)</b> 0-540-J3A5, -J3A5D, -J3C5D, -L3C5D; IO-540- W3A5D.	LW-19210 LW-19210	1 1	LW-15558 76788	2 2	Figure 2 Either Position Either Position
<b>Group 7 (6 Cyl. Direct Drive Integral Accessory Housing Engines)</b> TIO-541-A1A	76044 76044	1 1	76042 76043	2 2	Figure 2 Either Position Either Position

Any O-540-A1A model engine installed in a Piper aircraft must be converted to the O-540-A1A5 configuration at overhaul. This is accomplished by installing two (2) fifth order counterweight rollers P/N 72022, in place of two (2) of the four (4) sixth order P/N 70416 rollers, on one of the two (2) rear crankshaft lugs. When this modification has been completed, stamp the number "5" after the model number on the engine nameplate.

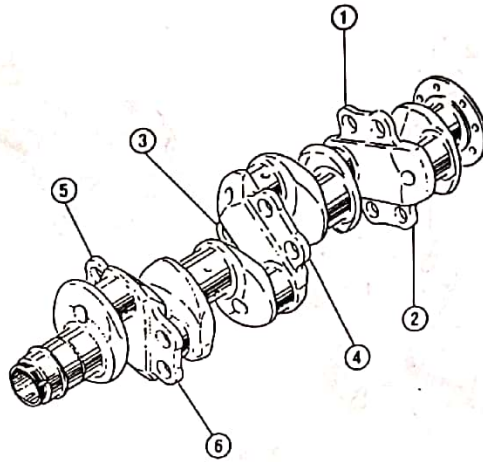
Figure 3.  
Counterweights and Rollers - Group 8, 9, 10, 11, 12, 13, 14

Group	Counterweights P/N	Qty. No.	Roller P/N	Qty. No.	Location Figure 3
Group 8 (6 Cyl. Geared Engines) GO-435-C2, -C2A, -C2A2, -C2B, -C2B1, -C2B2, -C2C, -C2E; GO-480-B series (except -B1A6, -B1E6) -C2C6, -C2D6, -D series; IGO-480-A1B6	LW-19225	6	69433	12	All Positions
Group 9 (6 Cyl. Geared Engines) GO-435-C2B2-6; GO-480-B1A6*, -B1E6, -C series; -F series, -G series; GSO-480 series (except -B1B3); IGSO-480 series (except -A1F3)	LW-19225 LW-19225 LW-19226	4 1 1	69433 70416 69433	8 2 2	Figure 3 Positions 1, 2, 3, 4 Position 6 Position 5
Group 10 (6 Cyl. Geared Engines) (Special) GO-480-B1A6 with the following S/N's: L-567-28, L-569-28, L-573-28, L-574-28, L-575-28, L-576-28.	LW-19225	6	70416	12	Figure 3 All Positions
Group 11 (6 Cyl. Geared Engines) GSO-480-B1B3; IGSO-480-A1F3.	LW-19210 LW-19213	2 4	76788 69433	4 8	Figure 3 Positions 1, 2 Positions 3, 4, 5, 6
Group 12 (6 Cyl. Geared Engines) IGO-540-A, -B series	LW-19213 LW-19225 LW-19226	4 1 1	73287 70416 73287	8 2 2	Figure 3 Positions 1, 2, 3, 4 Position 6 Position 5

Group 13 (6 Cyl. Geared Engines) IGSO-540-A, -B series	LW-19213 LW-19225 LW-19226	4 1 1	69433 70416 69433	8 2 2	Figure 3 Positions 1, 2, 3, 4 Position 6 Position 5
Group 14 (6 Cyl. Vertical Engines) VO-540-B1B3, -C1C3	LW-19213	6	73338	12	Figure 3 All Positions

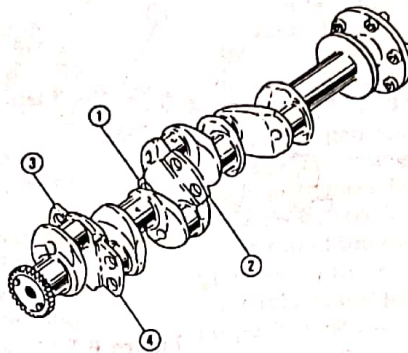
Figure 4.  
Counterweights and Rollers - Group 15

Group	Counterweights P/N	Qty. No.	Roller P/N	Qty. No.	Location Figure 4
Group 15* (6 Cyl. Direct Drive Integral Accessory Housing Engines) TIO-541-E1A4, -E1B4, S/N's 101-59 thru S/N's 297-59	75637	1	77386	2	Position 1
	76044	1	76042	2	Position 3
	76044	1	76043	2	Position 4
	75636	1	77385	2	Position 2
TIO-541-E1A4, -E1B4, S/N's 298-59 and up, -E1C4, -E1D4	75637	1	77386	2	Position 1
	76044	1	76042	2	Position 3
	76044	1	76043	2	Position 4
	78988 *	1	77385	2	Position 2

\* - Change 77887 crankshaft and counterweight assembly to 78989 at engine overhaul by using 78988 counterweight instead of 75636.

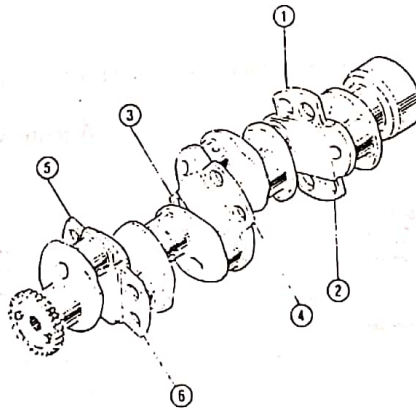
Figure 5.  
Counterweights and Rollers - Group 16

Group	Counterweights P/N	Qty. No.	Roller P/N	Qty. No.	Location Figure 5
Group 16 (6 Cyl. Geared Integral Accessory Housing Engines) TIGO-541-B1A, -D1A, -D1B, -E1A	75637	5	75631	10	Positions 2, 3, 4, 5, 6
	77002	1	77007	2	Position 1

When assembling TIGO-541 counterweight P/N 77002 to No. 1 position on the crankshaft, do not use 71906 or LW-14820 circlips and 71907 washers. Use washer P/N 77004 and circlip P/N 77005.

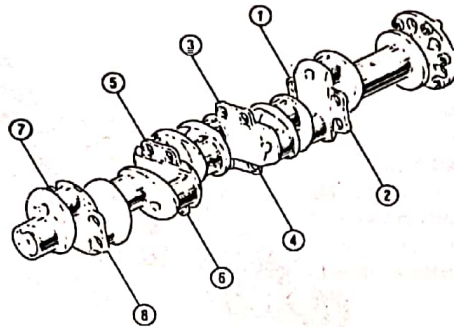
Figure 6.  
Counterweights and Rollers - Group 6

Group	Counterweights P/N	Qty. No.	Roller P/N	Qty. No.	Location
<b>Group 17 (8 Cyl. Direct Drive Engines)</b>					
IO-720-A, -B, -C, -D series	(73643) LW-19211	6	73649	12	Positions 1, 2, 4, 5, 7, 8
	(73812) LW-19212	1	73814	2	Position 3
	(73644) LW-19210	1	73648	2	Position 6

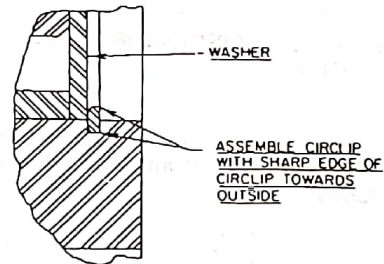
Figure 8.  
Assembly of Circlips in Counterweight

CIRCLIP P/N	"E" DIM	"F" DIM	GAGE	APPLICATION
71906	.892	.98	64892-2	ALL C/W'S
LW-14820	.892	.98	64892-2	ALL C/W'S
71005	1.132	2.45	64892-3	LARGE C/W ON 1500-541 OHLS

"E" DIM MINIMUM DISTANCE FROM BOTTOM OF GROOVE TO OPPOSITE EDGE OF CIRCLIP.  
"F" DIM MINIMUM GAP

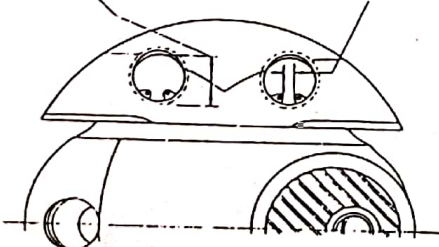
Figure 9.  
Diagram of Assembled Counterweight Showing Dimensions for Checking Circlip

CIRCLIP IDENTIFICATION			
FREE DIA	HOLE SIZE	STAMPED MARK	P/N
1.056	.072/.060	93	71906
1.056	.093/.076	N/A	LW-14820
1.344	.090/.076	N/A	71005

Install washers, P/N 71907 and circlips, P/N 71906 or LW-14820 on one side of the counterweight and place the counterweight on the proper crankshaft lobe. Insert the proper rollers and secure the assembly by installing washers and circlips on the other side of the counterweight (refer to figure 7). Circlips are inserted with the sharp edge outward (see figure 8). Two gages will check all circlips installed in any Textron Lycoming counterweight. See table with figure 9.

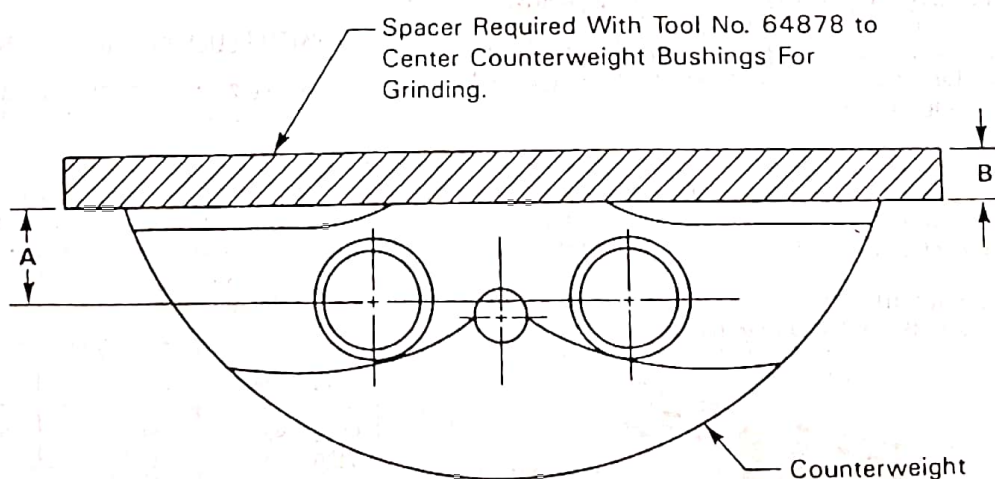
Counterweight Part No.	Spacer Detail Part No.	Dimensions		Weight (Lbs.) Minimum
		A	B ± .002	
71904	12	.825	.425	1.796
LW-19225D	27	.855	.395	1.796
LW-19225E	17	.875	.375	1.796
71905	12	.825	.425	1.752
LW-19226D	27	.855	.395	1.756
LW-19226E	17	.875	.375	1.756
72801	10	.715	.535	1.846
LW-19227D	28	.740	.510	1.846
LW-19227E*	30	.760	.490	1.846
72534	13	.950	.300	2.246
LW-19213	29	.965	.285	2.246
73643	15	.805	.445	2.212
LW-19211	12	.825	.425	2.212
73644	11	.741	.509	2.166
LW-19210	30	.761	.489	2.166
73812	15	.908	.342	2.266
LW-19212	31	.923	.327	2.266
74901	20	.720	.530	1.470
75636	20	.720	.530	1.600
75637	17	.875	.375	1.678
76044	18	.730	.520	1.810
78988	18	.730	.520	1.600

Figure 6. (Revised) Identification of Dimension "A" and "B"  
 (From Supplement No. 2 to Service Instruction No. 1143B, included for reference purposes)

Spacers are used with the P/N 64878 fixture to align the bushing bore of the counterweight with the center of the fixture. The "A" dimension from Figure 6 which is the distance from the center line of the counterweight bushing bore to the flat edge of the spacer. As can be seen in the table with Figure 6, the counterweights that are machined to the new specifications do not have the same "A" dimension as the counterweights that they replace. Owners of P/N 64878 fixtures who do not wish to purchase the P/N 64878-50 update kit can make the spacers required to align these new counterweights from hardened and ground steel using the dimensions

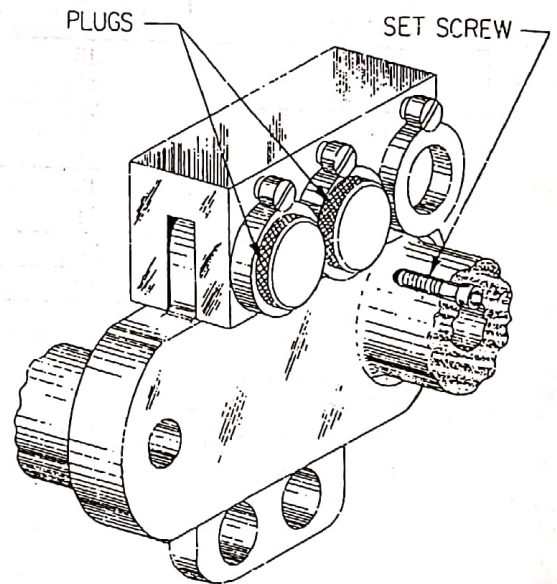
WITH PLUGS IN PLACE TIGHTEN SET SCREW

Figure 2. No. ST-280 Reaming Fixture Assembled to Crankshaft

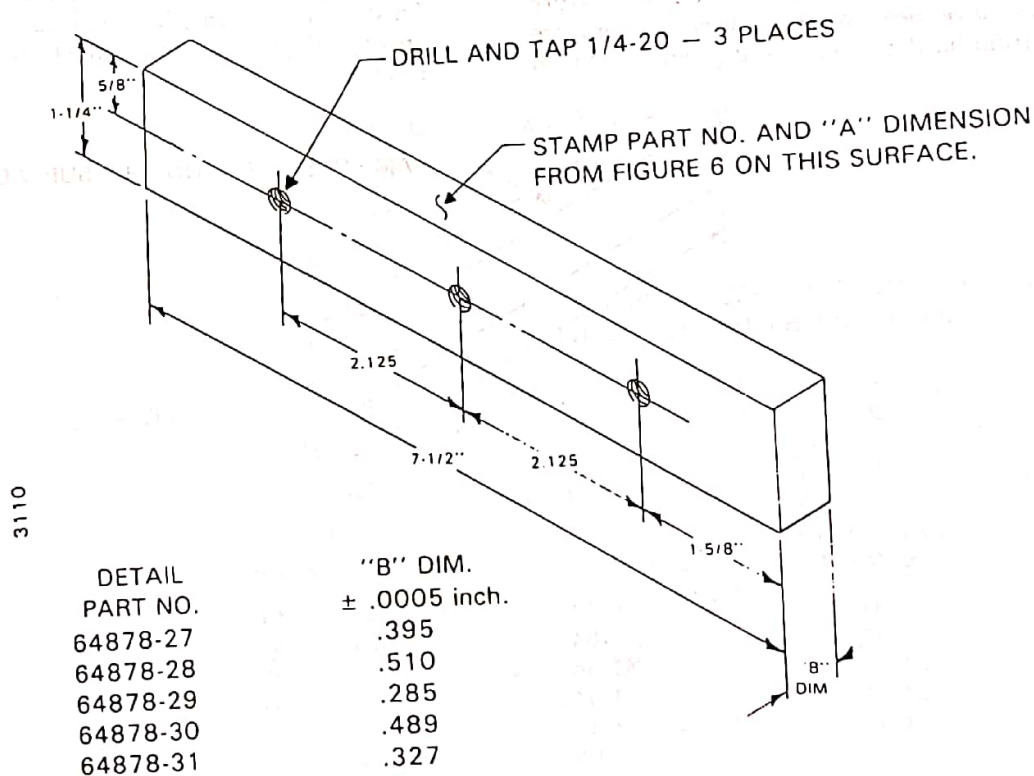
Figure 1. Dimensions of New Spacers for P/N 64878 Fixture

shown in Figure 1. Stamp or vibra-peen each spacer with the correct part number on a surface that will not interfere with counterweight alignment.

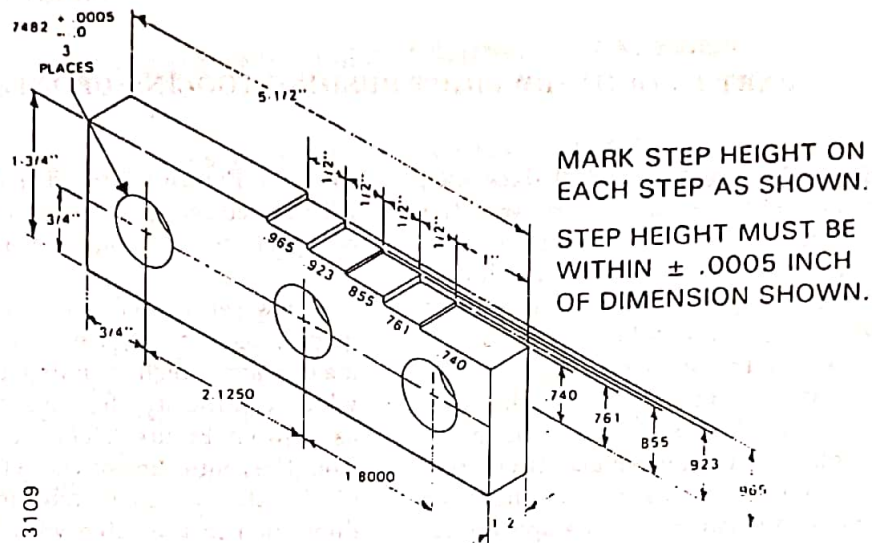
Figure 2. Dimensions of New Set Master P/N ST-94-10

A new set-master is required for the P/N ST-94 gaging fixture. Figure 2 illustrates the new set master and finish grinding dimension. Stamp or vibra-peen the step height dimension, on each step, as shown in Figure 2. This dimension is the distance from the center line of the set master to the surface of the step which can be matched with an "A" dimension in the table with Figure 6. This tool is made from oil hardened tool steel and ground to the finish dimensions.

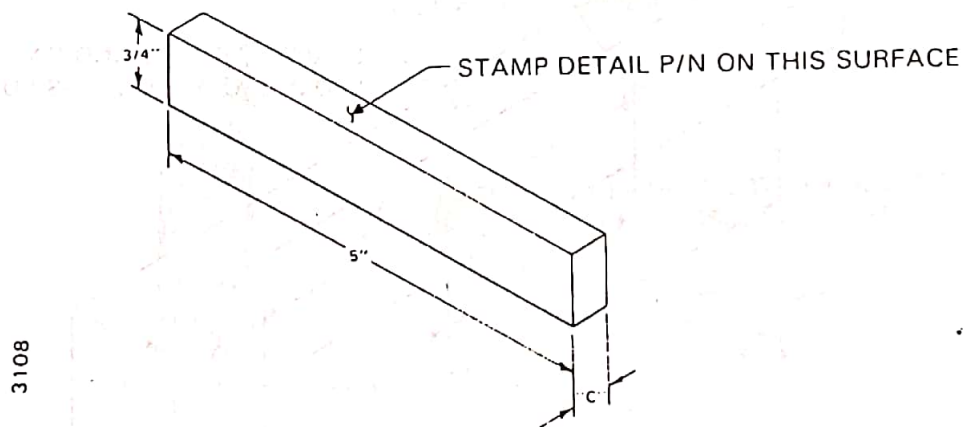
DETAIL PART NUMBER	DIMENSION "C"	USE WITH COUNTERWEIGHT P/N
ST-91-7	5/64	73643, 73644, 72534, 73812
ST-91-8	11/64	72801
ST-91-9	13/64	71904, 71905, LW-19210
ST-91-10	7/64	LW-19225, LW-19226, 75637
ST-91-11	7/32	LW-19227
ST-91-12	9/64	LW-19211
ST-91-13	1/32	LW-19212
ST-91-14	1/4	75636, 76044, 78988

Figure 3. Dimensions of New Spacers for ST-91 Gage

To insure the counterweight is properly and squarely mounted to the P/N ST-91, fixture spacers have been added. These spacers are made from hardened steel and ground to finish

dimensions. Refer to Figure 3 for part numbers, finished dimensions, and application of these spacers. Figures 9 and 10 illustrate use of the spacers.

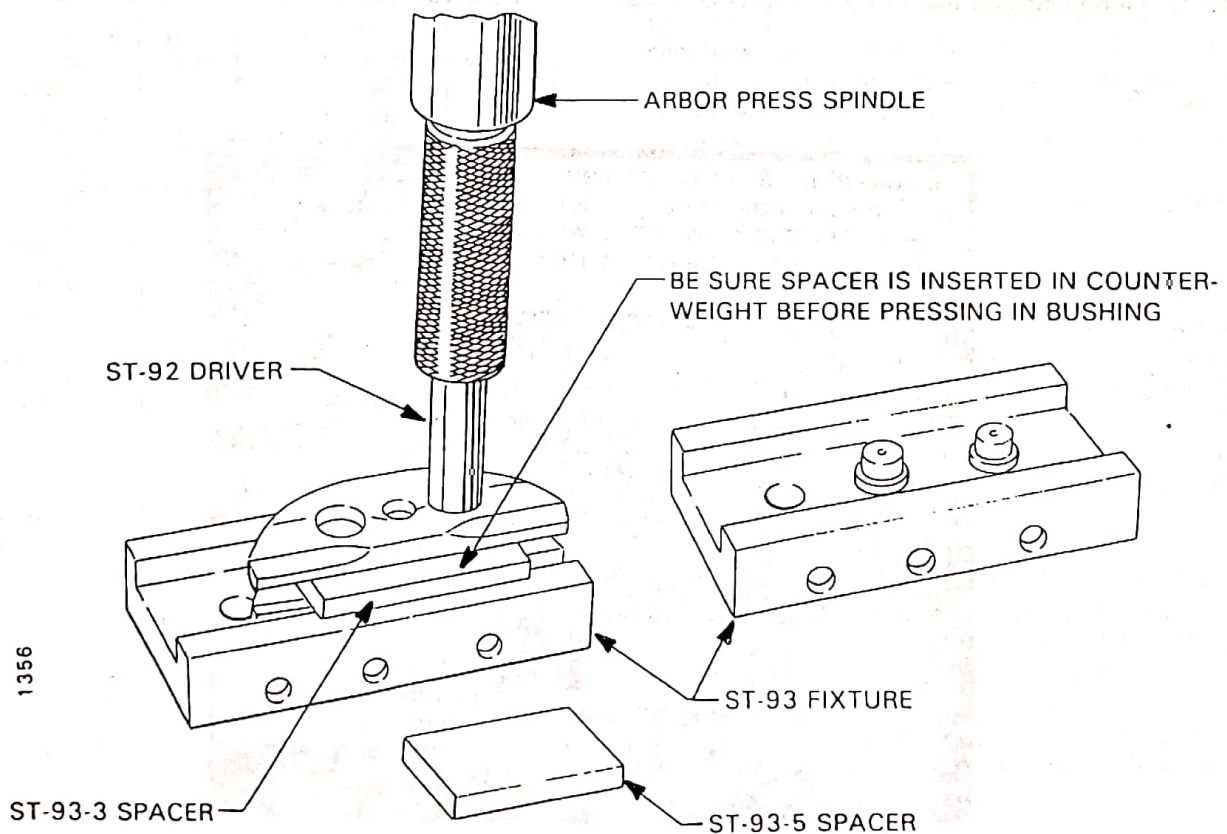
Figure 4. Installing Counterweight Bushing Using Fixture ST-93 and Driver ST-92

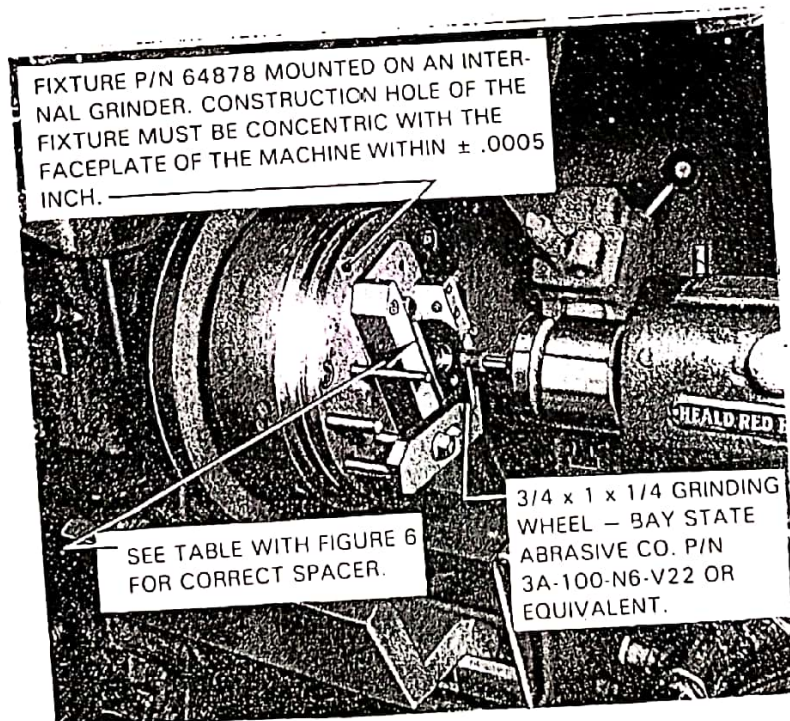
Figure 5. Counterweight and 64878 Fixture Assembled on an Internal Grinding Machine

The fixture P/N 64878 is sold without any mounting or locating holes drilled in its base. This allows the fixture to be mounted on any suitable machine without interference from pre-drilled holes.

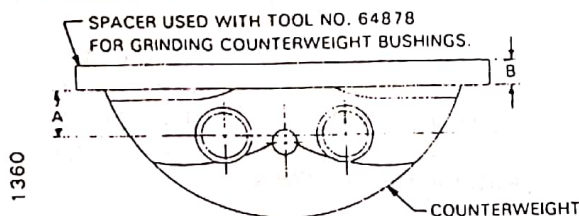
Counterweight Part No.	Spacer Detail Part No.	Dimensions		Weight (Lbs.) Minimum
		A	B $\pm .002$	
71904	12	.825	.425	1.796
LW-19225	27	.855	.395	1.796
71905	12	.825	.425	1.752
LW-19226	27	.855	.395	1.756
72801	10	.715	.535	1.846
LW-19227	28	.740	.510	1.846
72534	13	.950	.300	2.246
LW-19213	29	.965	.285	2.246
73643	15	.805	.445	2.212
LW-19211	12	.825	.425	2.212
73644	11	.741	.509	2.166
LW-19210	30	.761	.489	2.166
73812	16	.908	.342	2.266
LW-19212	31	.923	.327	2.266
74901	20	.720	.530	1.470
75636	20	.720	.530	1.600
75637	17	.875	.375	1.678
76044	18	.730	.520	1.810
78988	18	.730	.520	1.600

Figure 6. Identification of Dimension "A" and "B"

B. Select and install the correct spacer on the fixture and secure it to the alignment bar of the fixture with the three 1/4-20 socket head screws. The detail part number is stamped on the spacer. Refer to the table with Figure 6 for the correct spacer to use with each counterweight.

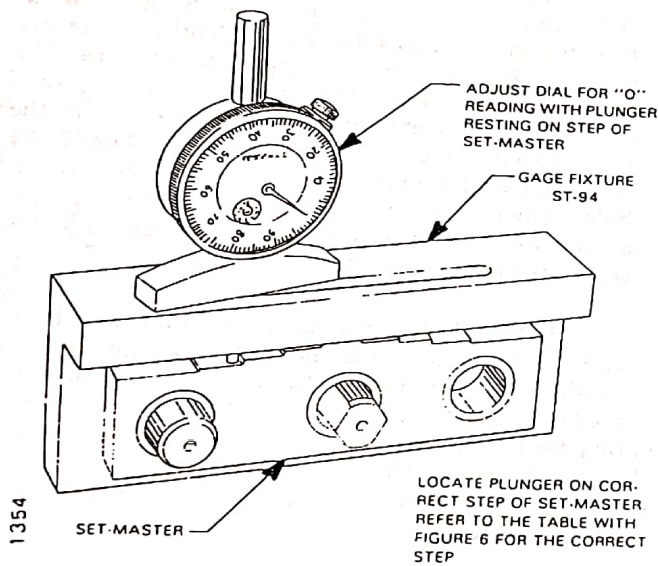
Figure 7. Depth Gage Adjusted with Set-Master Preparatory to Checking Line Position of Counterweight Bushings

B. Fixture P/N ST-94 is used to check the finished bushing bores for correct location. To set up the fixture, install the P/N ST-94-2 relieved locating pin in the center hole with the locating diameters in the vertical position as shown in Figure 7. Install the P/N ST-94-3 solid locating pin in the outside hole that has the same center to center distance as the counterweight bushing bores. The P/N ST-94-2 pin can remain permanently installed in the center hole with the P/N ST-94-3 being moved as required to adapt to the counterweight being inspected. If the pins do not fit into the newly ground bushing, it may be concluded that the bores are mislocated and the bushings must be replaced and reground again. If the counterweight fits, proceed to step C.

either P/N ST-94-5 or ST-94-10 set-master in the following manner. Place the set-master over the locating pins of the fixture (refer to Figure 7), preload the depth gage approximately .010 inch, set the dial gage to "0" with the plunger resting on the appropriate step of the set-master. The steps are identified by the "A" dimensions from the table with Figure 6. Remove the set-master and install the counterweight over the pins. Set the depth indicator thru the fixture and onto the counterweight. Refer to Figure 8. No more than  $\pm .004$  inch difference between this measurement and the measurement obtained with the set-master is allowed.

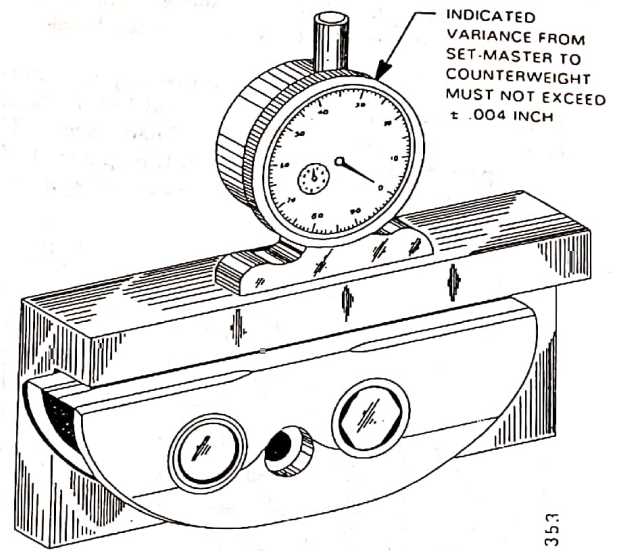
Figure 8. Checking Center Line Position of Counterweight Using Gage Fixture ST-94

During the following step (D) if erratic or excessively "out of limits" measurements are observed, remove the counterweight and insert it on the P/N ST-91 fixture so that the opposite inner face of the counterweight is located against the fixture. Then repeat the measurements. Only one of the inner faces of the counterweight is square with the bushing bores.

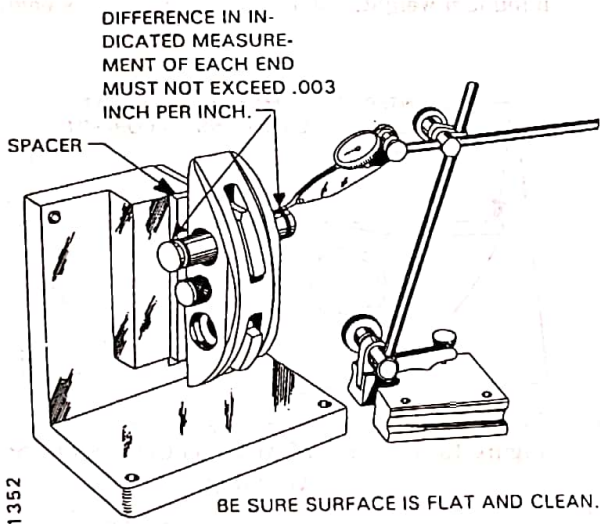
Figure 9. Checking Parallel and Squareness of Counterweight Bushings with Gage Fixture ST-91 - Vertical Position

D. Select the proper spacer either P/N ST-91-7, ST-91-8, ST-91-9, ST-91-10, ST-91-11, ST-91-12, ST-91-13, or ST-91-14 and install it and the counterweight on the fixture. Refer to Figure 3 for spacer application. Press the counterweight squarely against the spacer and tighten the knurled screw to secure the counterweight firmly against the locating surface of the fixture. Install the gaging arbors P/N ST-91-3 through each of the finished bushings as illustrated in Figure 6. Place the fixture on a surface plate and indicate both ends of each arbor as illustrated in Figure 9. Turn the fixture over to rest on its adjacent side and again indicate both ends of the gaging arbors. See Figure 10. The difference in measurements from one end of the gaging arbor to the other must not exceed .003 inch per inch in any instance.

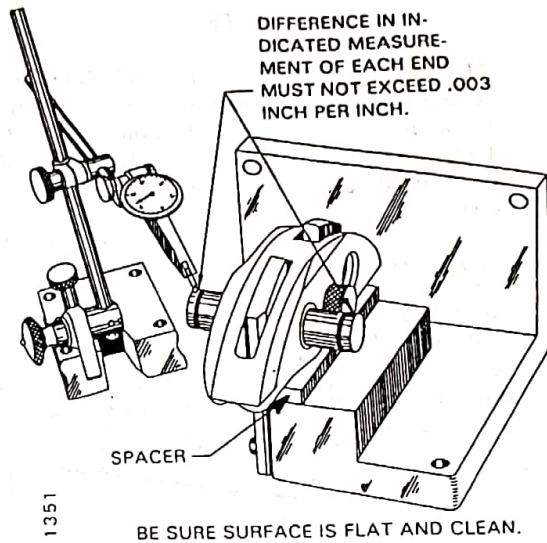
Figure 10. Checking Parallel and Squareness of Counterweight Bushings with Gage Fixture ST-91 - Horizontal Position

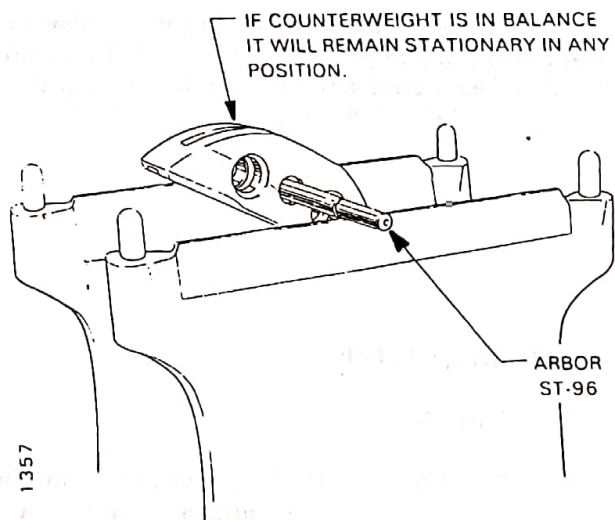
A. Install the counterweight on the correct P/N ST-96 balancing arbor, either the P/N ST-96-1 for the 3/8 inch hole or P/N ST-96-2 for the 1/4 inch hole, and place the arbor on a pair of balancing ways. Insure each blade of the ways engages the arbor at a point not more than 1-1/2" from each end.

Figure 11. Counterweight Mounted on ST-96 Arbor for Balancing

B. If the counterweight is in perfect balance it will remain in any position it is placed. See Figure 11. If it has a tendency to move, try to keep it in

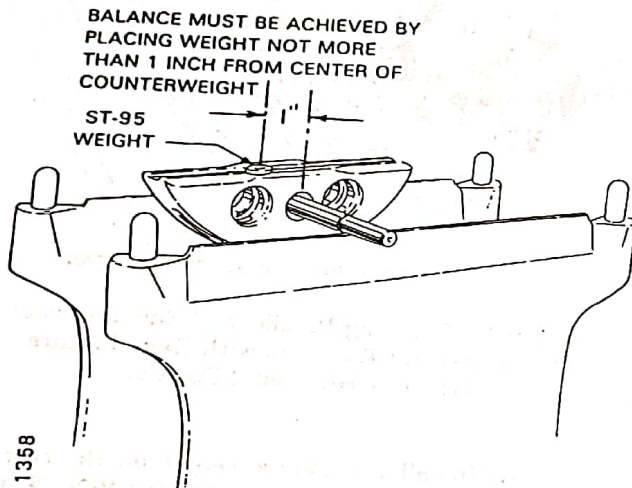
Figure 12. Counterweight Balanced by Weight ST-95 Placed Within One Inch from Center

balance by placing the center of the P/N ST-95 weight not more than 1" from the center of the arbor. See Figure 12. If the counterweight can be brought into balance with the addition of this weight the balance can be considered satisfactory.

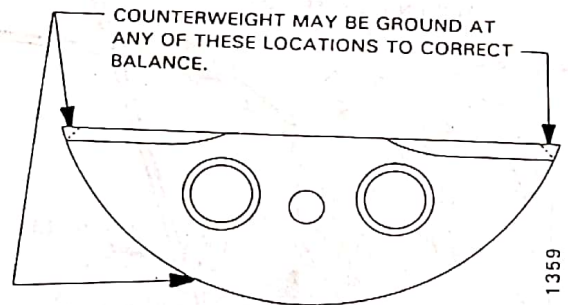
Figure 13. Location of Areas on Counterweight for Grinding

C. If the counterweight cannot be brought into balance by the addition of the P/N ST-95 weight, carefully grind the heavy end at the locations shown in Figure 13.

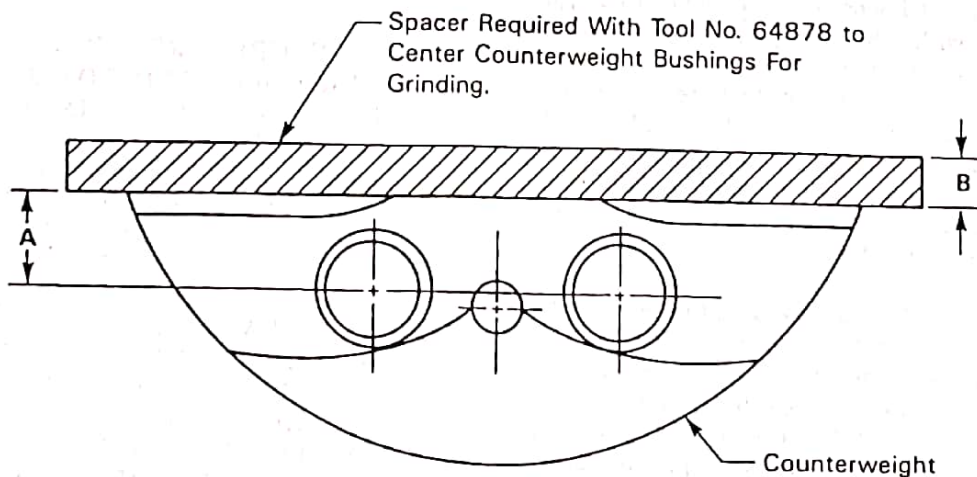
Counterweight Part No.	Spacer Detail Part No.	Dimensions		Weight (Lbs.) Minimum
		A	B ± .002	
71904	12	.825	.425	1.796
LW-19225D	27	.855	.395	1.796
LW-19225E	17	.875	.375	1.796
71905	12	.825	.425	1.752
LW-19226D	27	.855	.395	1.756
LW-19226E	17	.875	.375	1.756
72801	10	.715	.535	1.846
LW-19227D	28	.740	.510	1.846
LW-19227E*	30	.760	.490	1.846
72534	13	.950	.300	2.246
LW-19213	29	.965	.285	2.246
73643	15	.805	.445	2.212
LW-19211	12	.825	.425	2.212
73644	11	.741	.509	2.166
LW-19210	30	.761	.489	2.166
73812	16	.908	.342	2.266
LW-19212	31	.923	.327	2.266
74901	20	.720	.530	1.470
75636	20	.720	.530	1.600
75637	17	.875	.375	1.678
76044	18	.730	.520	1.810
78988	18	.730	.520	1.600

Figure 6. (Revised) Identification of Dimension "A" and "B"

8. Counterweight Weight Limitations - A weight check is not necessary unless the counterweight has been ground to correct an improper balance condition. If the counterweight has been ground it must meet the minimum weight requirements shown in the table with Figure 6. Do not install any counterweight weighing less than the minimum weight, listed in the table, in any engine.

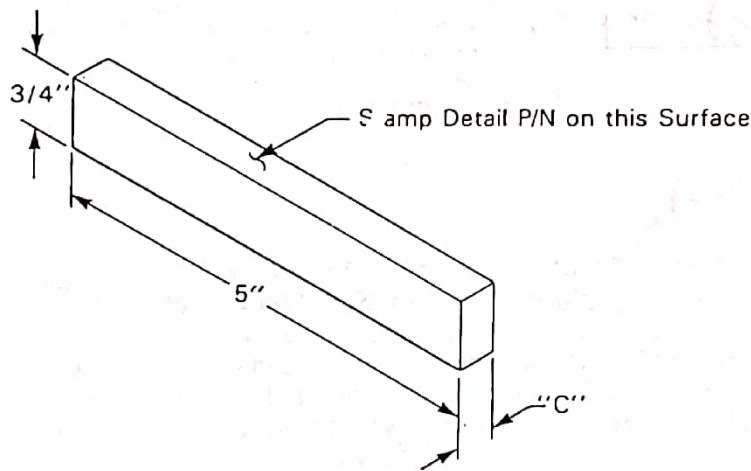
DETAIL PART NUMBER	DIMENSION "C"	USE WITH COUNTERWEIGHT P/N
ST-91-7	$\frac{5}{64}$	73643, 73644, 72534, 73812
ST-91-8	$\frac{11}{64}$	72801, LW-19225E, LW-19226E
ST-91-9	$\frac{13}{64}$	71904, 71905, LW-19210
ST-91-10	$\frac{7}{64}$	LW-19225D, LW-19226D, 75637
ST-91-11	$\frac{7}{32}$	LW-19227D
ST-91-12	$\frac{9}{64}$	LW-19211, LW-19227E
ST-91-13	$\frac{1}{32}$	LW-19212
ST-91-14	$\frac{1}{4}$	75636, 76044, 78988

Figure 3. (Revised) Dimensions of New Spacers for ST-91 Gage

3. Figure 3 is revised and included with this Supplement, to show spacer application for the revised counterweights. Figure 3A is added to illustrate an undercut to the P/N ST-91-6 knurled screw. This undercut is required to allow use of existing spacers with the revised counterweights.

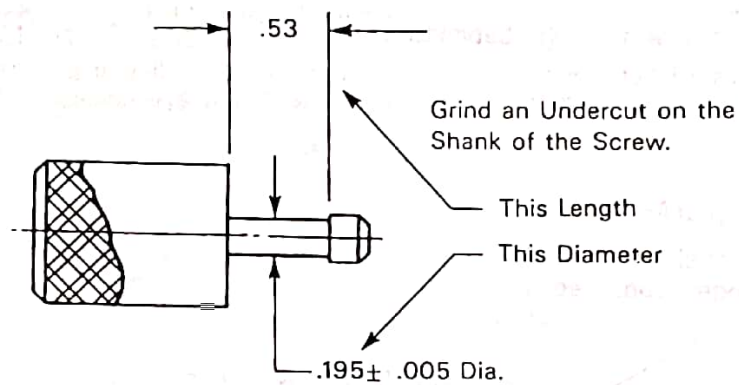
Figure 3A. Modifications to P/N ST-91-6 Knurled Screw

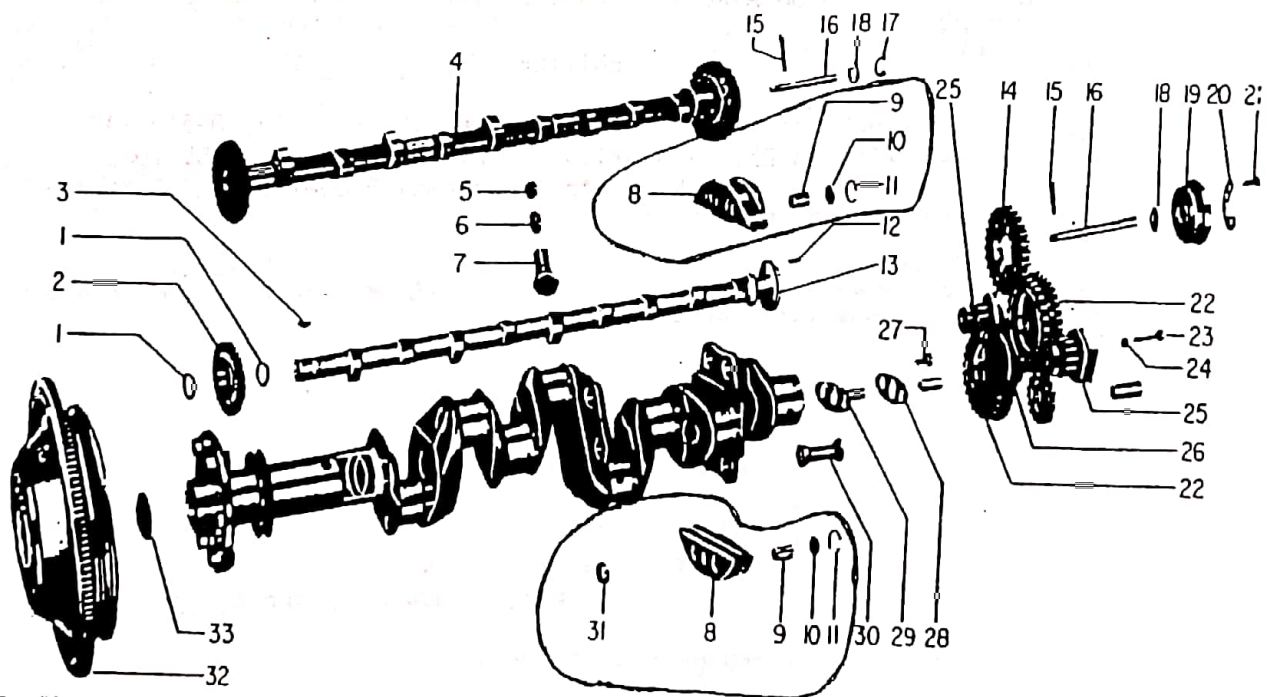
Use Figure 1 (Typical Crankshaft and Related Parts) as shown below to aid in Counterweight Removal and Installation.

1. Remove the two (2) Lycoming Counterweights, P/N 71904, and (2) rollers, P/N 70416 and (2) P/N 72022, merely by removing the retaining rings, ref. 11, after which the Washers, ref. 10, Rollers, ref. 9, and Counterweights, ref. 8, may be detached from the Crankshaft Lug.
2. After removing 71904 Counterweights and prior to installing 72801 Counterweights, dimensionally check bushings in Crankshaft Counterweight Cheeks. Any bushings not meeting New Lycoming specifications must be replaced per latest version of Lycoming Service Instruction 1142.

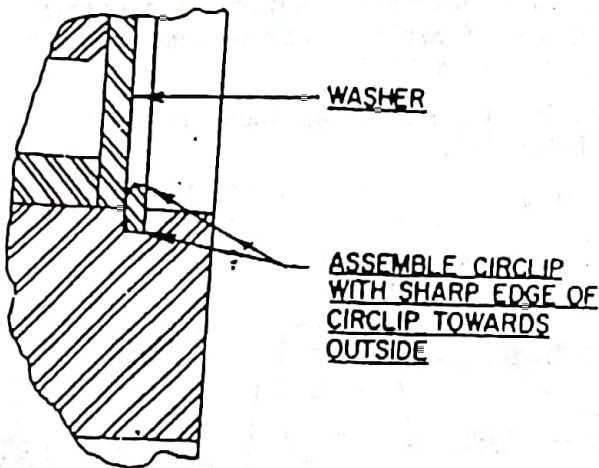
Figure 2  
Assembly of Circlips in Counterweight

- Per Lycoming Service Instruction 1012 (Latest Version), install New 71907 Washers, ref. 10, and New LW14820 (71906) Retaining Rings, ref. 11, on one side of New Style Rebuilt or New Counterweight Assembly, P/N 72801, ref. 8, and place the Counterweight on its proper lug on the Crankshaft per Figure 4 Service Instruction 1012 (latest version). Insert (2) New Rollers, P/N 72797, ref. 9, and secure assembly by installing New 71907 Washers and LW 14820 (71906) Circlips on the other side of the Counterweight. All the Bushings, P/N 71903, in the Counterweights must be New and Finished per Lycoming Service Instruction 1143 (latest version). Circlips are inserted with sharp edge outward (see Figure 2). Two gages will check all circlips in any Avco Lycoming Counterweight. See table on Figure 3.

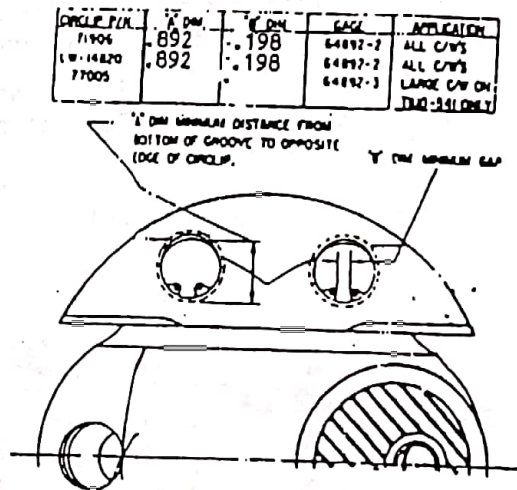
Figure 3  
Diagram of Assembled Counterweight  
Showing Dimensions for Checking Circlip

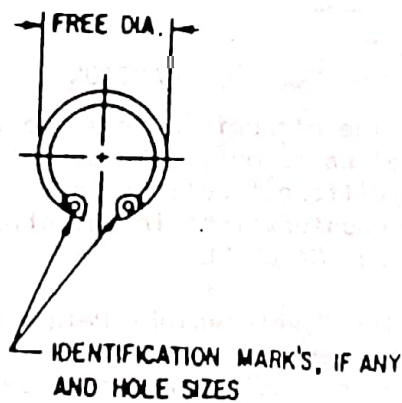
FREE DIA.	HOLE SIZE	STAMPED MARK	P/N
1.056	.072/.060	93	71906
1.056	.093/.076	N/A	LW-14820
1.344	.090/.076	N/A	77005

**Figure 4 Circlip Identification**

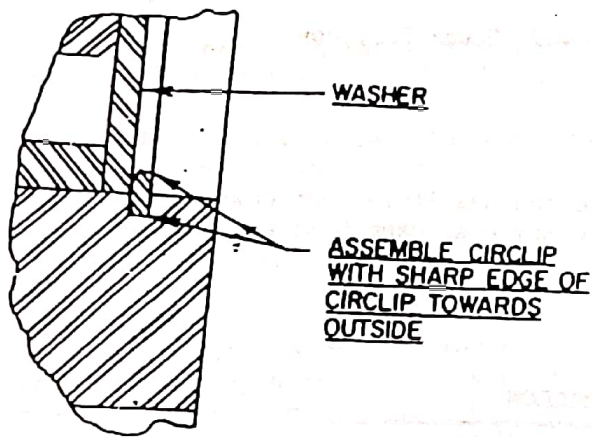
Figure 2  
Assembly of Circlips in Counterweight

- Per Lycoming Service Instruction 1012 (Latest Version), install New 71907 Washers, ref. 10, and New LW14820 (71906) Retaining Rings, ref. 11, on one side of New Style Rebuilt or New Counterweight Assembly, P/N 72801, ref. 8, and place the Counterweight on its proper lug on the Crankshaft per Figure 4 Service Instruction 1012 (latest version). Insert (2) New Rollers, P/N 72797, ref. 9, and secure assembly by installing New 71907 Washers and LW 14820 (71906) Circlips on the other side of the Counterweight. All the Bushings, P/N 71903, in the Counterweights must be New and Finished per Lycoming Service Instruction 1143 (latest version). Circlips are inserted with sharp edge outward (see Figure 2). Two gages will check all circlips in any Avco Lycoming Counterweight. See table on Figure 3.

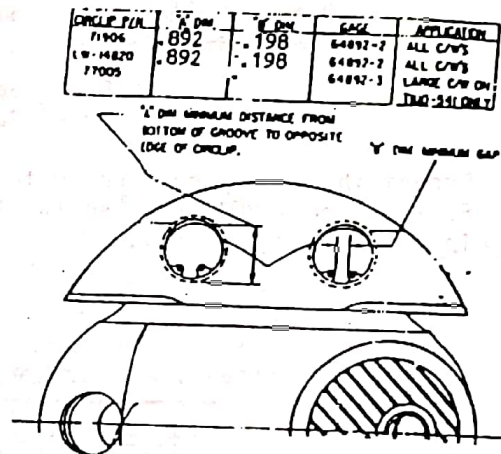
Figure 3  
Diagram of Assembled Counterweight Showing Dimensions for Checking Circlip

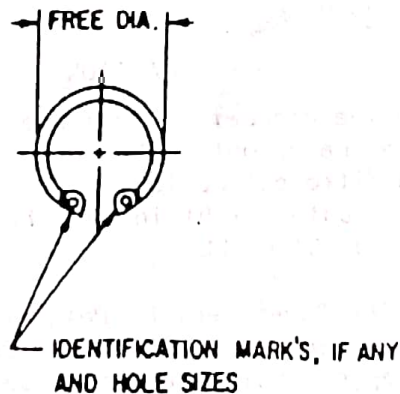
FREE DIA.	HOLE SIZE	STAMPED MARK	P/N
1.056	.072/.060	93	71906
1.056	.093/.076	N/A	LW-14820
1.344	.090/.076	N/A	77005

**Figure 4 Circlip Identification**

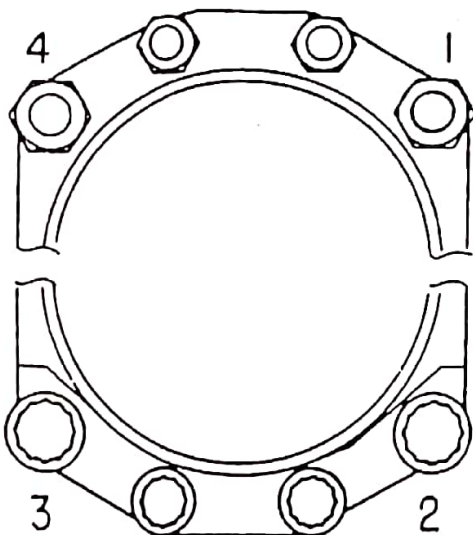
Figure 5 Sequence for Tightening Cylinder Base nuts

4. Check  $\frac{3}{8}$  inch nuts for tightness on the remaining cylinder base studs by bringing torque up to 300 in.lb (25ft.lb). Sequence is optional.

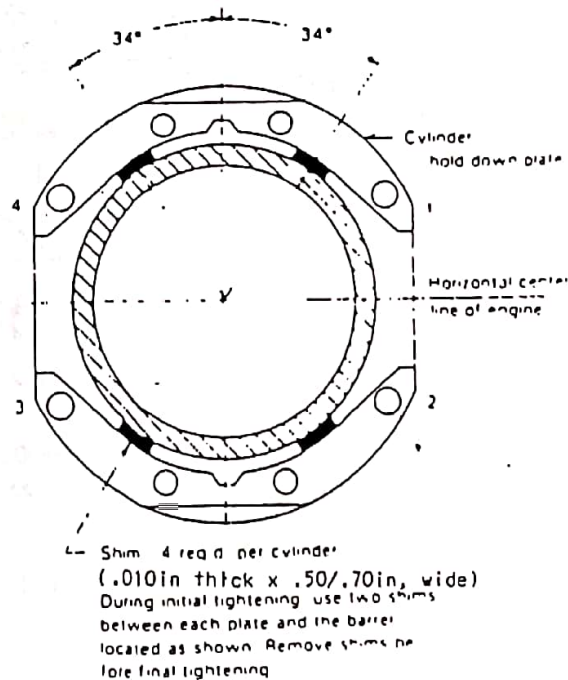
Figure 6 Location of Shims Between Cylinder Barrel and Hold-Down Plates

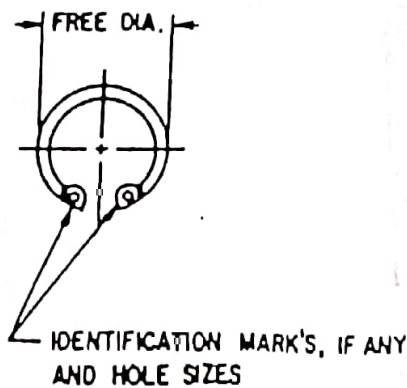
FREE DIA.	HOLE SIZE	STAMPED MARK	P/N
1.056	.072/.060	93	71906
1.056	.093/.076	N/A	LW-14820
1.344	.090/.076	N/A	77005

Figure 4 Circlip Identification

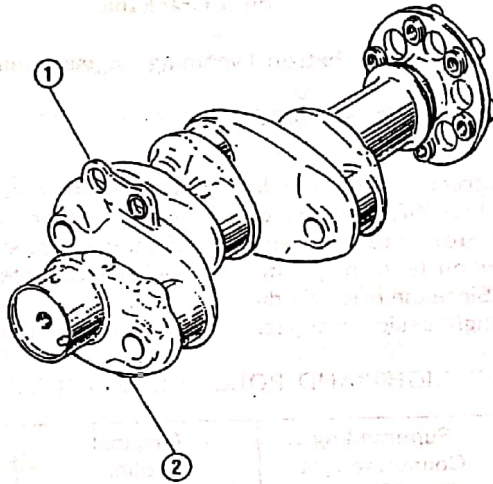
Figure 1.  
Counterweights and Rollers - Group 1

Group	Counterweights P/N	Qty. No.	Roller P/N	Qty. No.	Location
<b>Group 1 (4 Cyl. Direct Drive Engines)</b>					Figure 1
0-360-A1F6, -A1F6D, -A1G6, -A1G6D, -E1A6D, -F1A6, -G1A6; LO-360-A1G6D, -E1A6D; IO-360- A1B6, -A1B6D, -A1D6, -A1D6D, -A3B6D, -A3D6D, -B2F6, -C1C6, -C1D6, -C1E6, -J1A5D; AEIO-360-A1B6, -B1G6; LIO-360-C1E6; TO-360- C1A6D, -E1A6D, -F1A6D; LTO-360-E1A6D; TIO- 360-A3B6, -C1A6D.	LW-19227 LW-19227	1 1	LW-10977 LW-10945	2 2	Either Position Either Position

Part I separates applicable engines into groups that utilize the same basic crankshaft design with the same counterweight and roller configuration. The location column in the table that accompanies each group references the group to a numbered figure which is an illustration that is typical of the crankshaft installed in the engines listed with the group. Each counterweight lobe position is numbered on the illustration and the location column in the table assigns each counterweight and roller combination to one or more of these numbered positions.

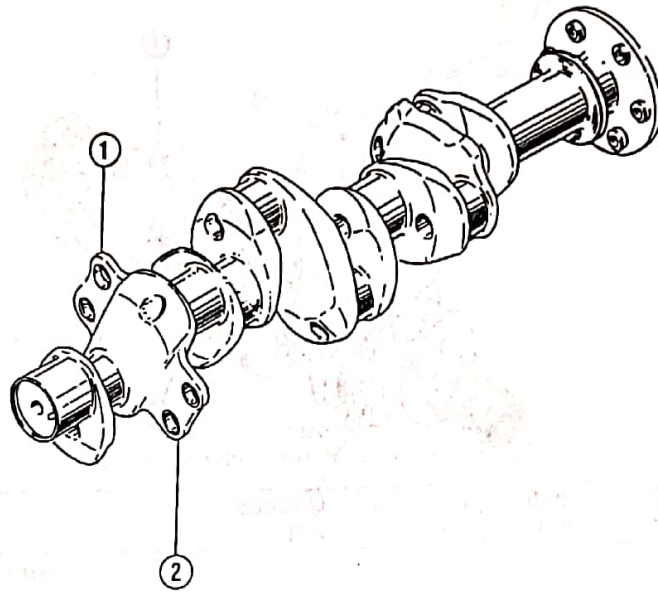
Figure 2.  
Counterweights and Rollers - Group 2, 3, 4, 5, 6, 7

Group	Counterweights P/N	Qty. No.	Roller P/N	Qty. No.	Location
<b>Group 2 (6 Cyl. Direct Drive Engines)</b> 0-540-A1D, -A2B.	LW-19225	2	70416	4	Figure 2 Position 1, 2
<b>Group 3 (6 Cyl. Direct Drive Engines)</b> 0-540-A1A, -A1A5, -A1B5, -A1C5, -A1D5, -A3D5, -B1A5, -B1B5, -B2B5, -B2C5, -F1A5, -F1B5, -G1A5, -G2A5, -H1B5D, -H2A5, -H2B5D; IO-540-C1B5, -C1C5.	LW-19225 LW-19225	1 1	70416 72022	2 2	Figure 2 Either Position Either Position
<b>Group 4 (6 Cyl. Direct Drive Engines)</b> 0-540-A4D5, -B4B5, -E4A5, -E4B5, -E4C5, -J1A5D; IO-540-A1A5, -B1A5, -B1B5, -B1C5, -C1B5, -C4B5, -C4C5, -C4D5D, -D4A5, -E1A5, -E1B5, -G1A5, -G1B5, -G1C5, -G1D5, -G1E5, -G1F5, -J4A5, -P1A5, -T4A5D, -T4B5D, -T4C5D, -W1A5D; AEIO-540-D4A5, -D4B5, -L1B5D; TIO- 540-C1A, -E1A, -G1A, -H1A, -AA1A5, -AB1AD.	LW-19227 LW-19227	1 1	72965 72797	2 2	Figure 2 Either Position Either Position
<b>Group 5 (6 Cyl. Direct Drive Engines)</b> IO-540-K1A5, -K1A5D, -K1B5, -K1C5, -K1D5, -K1E5, K1E5D, -K1F5, -K1F5D, -K1G5, -K1G5D, -K1H5, -K1J5, -K1J5D, -K1K5, -L1A5, -L1A5D, -L1B5D, -L1C5, -M1A5, -M1A5D, -M1B5D, -M2A5D, -N1A5, -R1A5, -R1A5D, -S1A5, -U1B5D, -AA1A5; AEIO-540-L1B5D; HIO-540-A1A; TIO-540-A1A, -A1B, -A2A, -A2B, -A2C, -F2BD, -J2B, -J2BD, -N2BD, -R2AD, -S1AD, -T2AD, -U2A, -V2AD, -W2A; LTIO-540- F2BD, -J2B, -J2BD, -N2BD, -U2A, -V2AD, -W2A.	LW-19210 LW-19210	1 1	73648 76788	2 2	Figure 2 Either Position Either Position

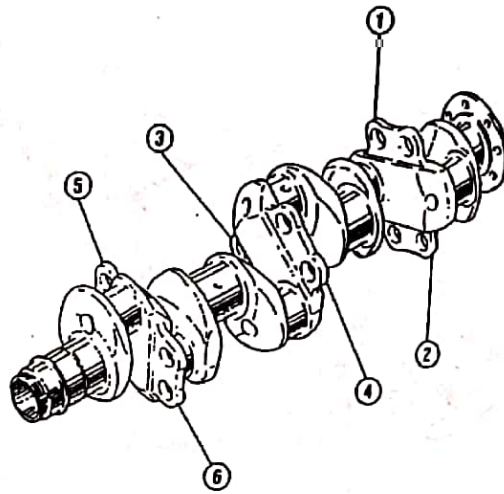
Figure 3.  
Counterweights and Rollers - Group 8, 9, 10, 11, 12, 13, 14

Group	Counterweights P/N	Qty. No.	Roller P/N	Qty. No.	Location
<b>Group 8 (6 Cyl. Geared Engines)</b> GO-435-C2, -C2A, -C2A2, -C2B, -C2B1, -C2B2, -C2C, -C2E; GO-480-B series (except -B1A6, -B1E6) -C2C6, -C2D6, -D series; IGO-480-A1B6	LW-19225	6	69433	12	Figure 3 All Positions
<b>Group 9 (6 Cyl. Geared Engines)</b> GO-435-C2B2-6; GO-480-B1A6*, -B1E6, -C series; -F series, -G series; GSO-480 series (except -B1B3); IGSO-480 series (except -A1F3)	LW-19225 LW-19225 LW-19226	4 1 1	69433 70416 69433	8 2 2	Figure 3 Positions 1, 2, 3, 4 Position 6 Position 5
<b>Group 10 (6 Cyl. Geared Engines) (Special)</b> GO-480-B1A6 with the following S/N's: L-567-28, L-569-28, L-573-28, L-574-28, L-575-28, L-576-28.	LW-19225	6	70416	12	Figure 3 All Positions
<b>Group 11 (6 Cyl. Geared Engines)</b> GSO-480-B1B3; IGSO-480-A1F3.	LW-19210 LW-19213	2 4	76788 69433	4 8	Figure 3 Positions 1, 2 Positions 3, 4, 5, 6
<b>Group 12 (6 Cyl. Geared Engines)</b> IGO-540-A, -B series	LW-19213 LW-19225 LW-19226	4 1 1	73287 70416 73287	8 2 2	Figure 3 Positions 1, 2, 3, 4 Position 6 Position 5
