**MAJOR REPAIR AND ALTERATION**  
(Airframe, Powerplant, Propeller, or Appliance)

1. Aircraft	Nationality and Registration Mark USA N9456P	Serial No. 24-4974
	Make Piper	Model PA-24-260
2. Owner	Name (As shown on registration certificate) N9456P LLC	Address (As shown on registration certificate) Address 5901 N. Grand Canyon Dr. City Las Vegas State NV Zip 89149 Country USA

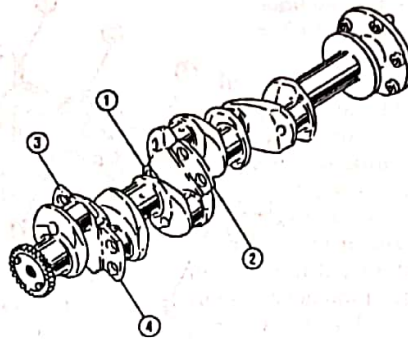
Figure 4.  
Counterweights and Rollers - Group 15

Group	Counterweights P/N	Qty. No.	Roller P/N	Qty. No.	Location
<b>Group 15* (6 Cyl. Direct Drive Integral Accessory Housing Engines)</b>					<b>Figure 4</b>
TIO-541-E1A4, -E1B4, S/N's 101-59 thru S/N's 297-59	75637	1	77386	2	Position 1
	76044	1	76042	2	Position 3
	76044	1	76043	2	Position 4
	75636	1	77385	2	Position 2
TIO-541-E1A4, -E1B4, S/N's 298-59 and up, -E1C4, -E1D4	75637	1	77386	2	Position 1
	76044	1	76042	2	Position 3
	76044	1	76043	2	Position 4
	78988 *	1	77385	2	Position 2

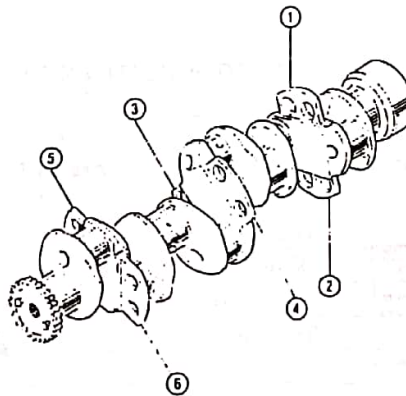
Figure 5.  
Counterweights and Rollers - Group 16

Group	Counterweights P/N	Qty. No.	Roller P/N	Qty. No.	Location
<b>Group 16 (6 Cyl. Geared Integral Accessory Housing Engines)</b>					<b>Figure 5</b>
TIGO-541-B1A, -D1A, -D1B, -E1A	75637	5	75631	10	Positions 2, 3, 4, 5, 6
	77002	1	77007	2	Position 1

When assembling TIGO-541 counterweight P/N 77002 to No. 1 position on the crankshaft, do not use 71906 or LW-14820 circlips and 71907 washers. Use washer P/N 77004 and circlip P/N 77005.

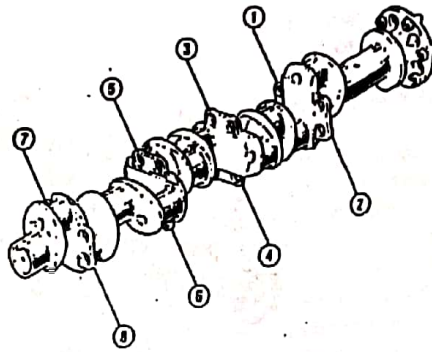
Figure 6.  
Counterweights and Rollers - Group 6

Group	Counterweights P/N	Qty. No.	Roller P/N	Qty. No.	Location
Group 17 (8 Cyl. Direct Drive Engines)					
Figure 6					
10-720-A, -B, -C, -D series	(73643) LW-19211	6	73649	12	Positions 1, 2, 4, 5, 7, 8
	(73812) LW-19212	1	73814	2	Position 3
	(73644) LW-19210	1	73648	2	Position 6

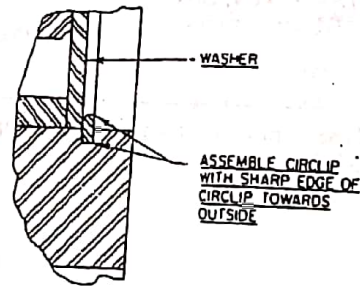
Figure 8.  
Assembly of Circlips in Counterweight

Install washers, P/N 71907 and circlips, P/N 71906 or LW-14820 on one side of the counterweight and place the counterweight on the proper crankshaft lobe. Insert the proper rollers and secure the assembly by installing washers and circlips on the other side of the counterweight (refer to figure 7). Circlips are inserted with the sharp edge outward (see figure 8). Two gages will check all circlips installed in any Textron Lycoming counterweight. See table with figure 9.

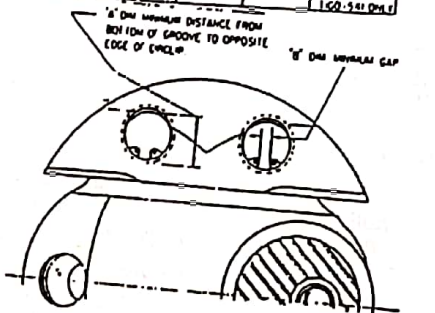
CIRCLIP P/N	"A" DIM	"B" DIM	GAGE	APPLICATION
71906	872	998	64892-2	ALL C/W'S
LW-14820	892	998	64892-2	ALL C/W'S
71005	1132	245	64892-3	LARGE C/W OH 1600-541 OHLE

Figure 9.  
Diagram of Assembled Counterweight  
Showing Dimensions for Checking Circlip

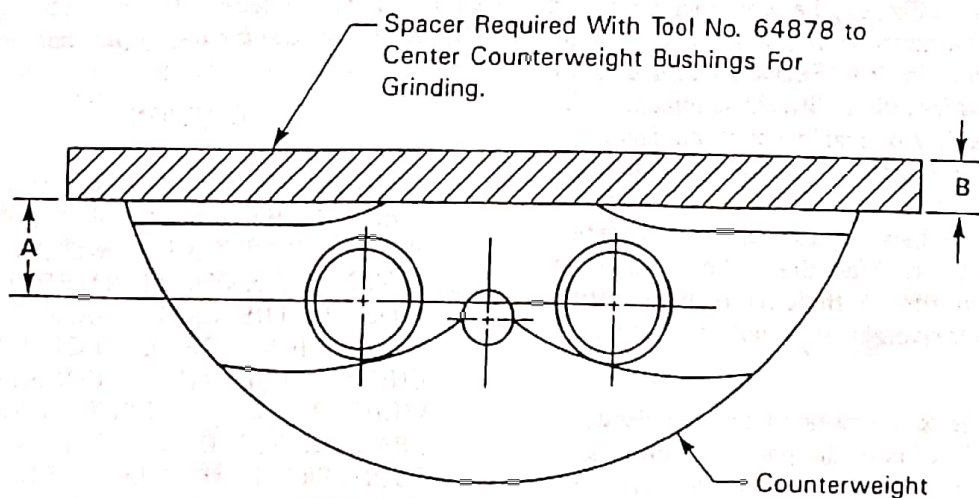
Counterweight Part No.	Spacer Detail Part No.	Dimensions		Weight (Lbs.) Minimum
		A	B ± .002	
71904	12	.825	.425	1.796
LW-19225D	27	.855	.395	1.796
LW-19225E	17	.875	.375	1.796
71905	12	.825	.425	1.752
LW-19226D	27	.855	.395	1.756
LW-19226E	17	.875	.375	1.756
72801	10	.715	.535	1.846
LW-19227D	28	.740	.510	1.846
LW-19227E*	30	.760	.490	1.846
72534	13	.950	.300	2.246
LW-19213	29	.965	.285	2.246
73643	15	.805	.445	2.212
LW-19211	12	.825	.425	2.212
73644	11	.741	.509	2.166
LW-19210	30	.761	.489	2.166
73812	16	.908	.342	2.266
LW-19212	31	.923	.327	2.266
74901	20	.720	.530	1.470
75636	20	.720	.530	1.600
75637	17	.875	.375	1.678
76044	18	.730	.520	1.810
78988	18	.730	.520	1.600

Figure 6. (Revised) Identification of Dimension "A" and "B"  
 (From Supplement No. 2 to Service Instruction No. 1143B, included for reference purposes)

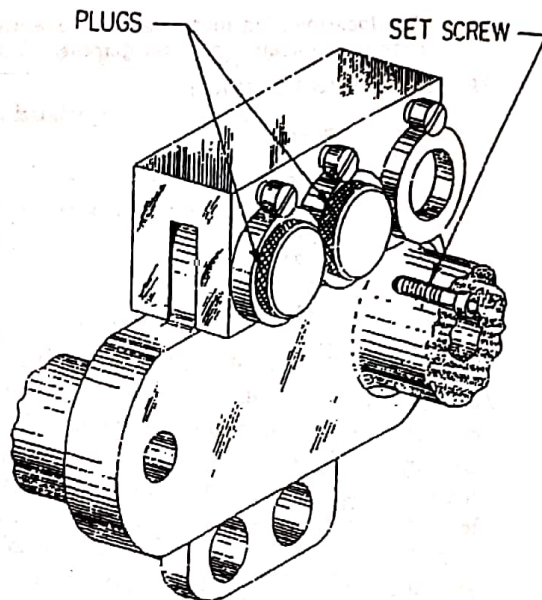
WITH PLUGS IN PLACE TIGHTEN SET SCREW

Figure 2. No. ST-280 Reaming Fixture Assembled to Crankshaft

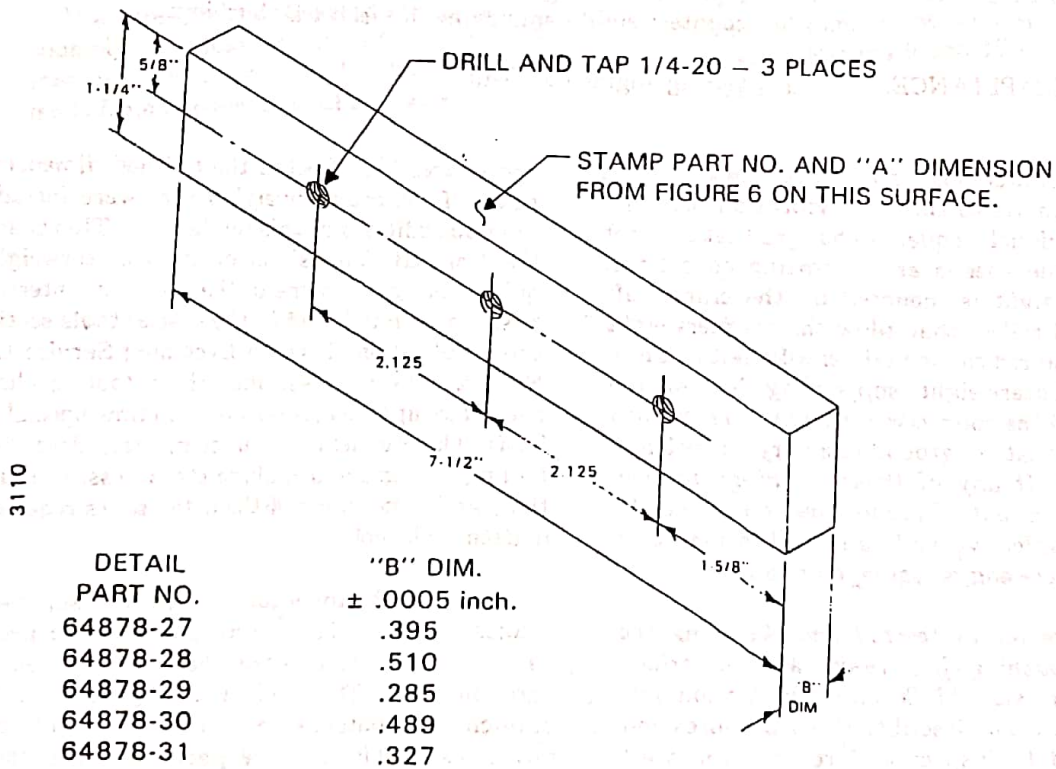
Figure 1. Dimensions of New Spacers for P/N 64878 Fixture

Spacers are used with the P/N 64878 fixture to align the bushing bore of the counterweight with the center of the fixture. The "A" dimension from Figure 6 which is the distance from the center line of the counterweight bushing bore to the flat edge of the spacer. As can be seen in the table with Figure 6, the counterweights that are machined to the new specifications do not have the same "A" dimension as the counterweights that they replace. Owners of P/N 64878 fixtures who do not wish to purchase the P/N 64878-50 update kit can make the spacers required to align these new counterweights from hardened and ground steel using the dimensions

shown in Figure 1. Stamp or vibra-peen each spacer with the correct part number on a surface that will not interfere with counterweight alignment.

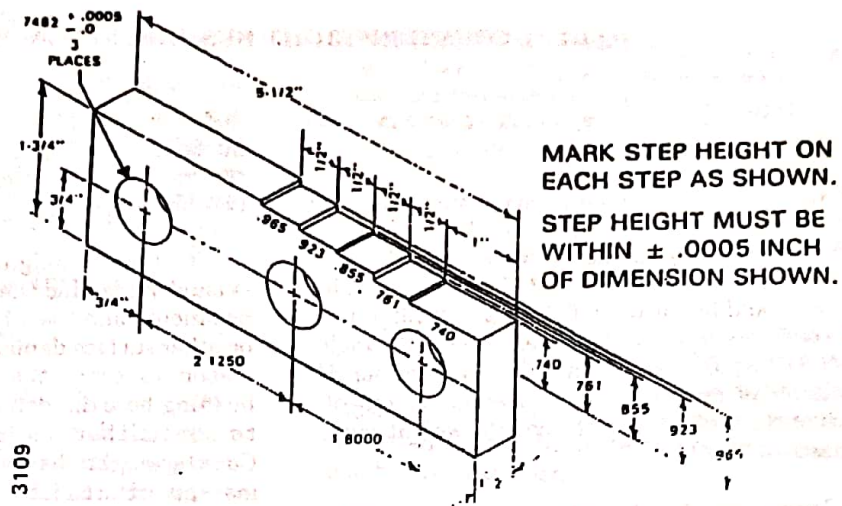
Figure 2. Dimensions of New Set Master P/N ST-94-10

A new set-master is required for the P/N ST-94 gaging fixture. Figure 2 illustrates the new set master and finish grinding dimensions. Stamp or vibra-peen the step height dimension, on each step, as shown in Figure 2. This dimension is the distance from the center line of the set master to the surface of the step which can be matched with an "A" dimension in the table with Figure 6. This tool is made from oil hardened tool steel and ground to the finish dimensions.

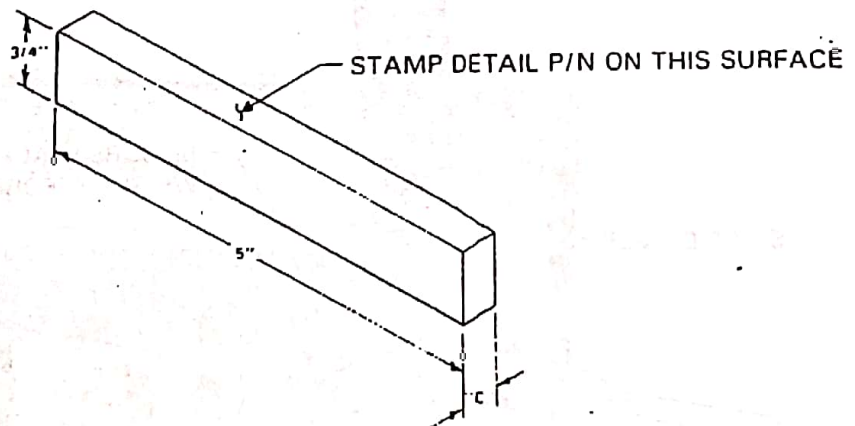
Figure 3. Dimensions of New Spacers for ST-91 Gage

To insure the counterweight is properly and squarely mounted to the P/N ST-91, fixture spacers have been added. These spacers are made from hardened steel and ground to finish

dimensions. Refer to Figure 3 for part numbers, finished dimensions, and application of these spacers. Figures 9 and 10 illustrate use of the spacers.

DETAIL PART NUMBER	DIMENSION "C"	USE WITH COUNTERWEIGHT P/N
ST-91-7	5/64	73643, 73644, 72534 73812
ST-91-8	11/64	72801
ST-91-9	13/64	71904, 71905, LW-19210
ST-91-10	7/64	LW-19225, LW 19226, 75637
ST-91-11	7/32	LW-19227
ST-91-12	9/64	LW-19211
ST-91-13	1/32	LW-19212
ST-91-14	1/4	75636, 76044, 78988

D. Select the proper spacer either P/N ST-91-7, ST-91-8, ST-91-9, ST-91-10, ST-91-11, ST-91-12, ST-91-13, or ST-91-14 and install it and the counterweight on the fixture. Refer to Figure 3 for spacer application. Press the counterweight squarely against the spacer and tighten the knurled screw to secure the counterweight firmly against the locating surface of the fixture. Install the gaging arbors P/N ST-91-3 through each of the finished bushings as illustrated in Figure 6. Place the fixture on a surface plate and indicate both ends of each arbor as illustrated in Figure 9. Turn the fixture over to rest on its adjacent side and again indicate both ends of the gaging arbors. See Figure 10. The difference in measurements from one end of the gaging arbor to the other must not exceed .003 inch per inch in any instance.

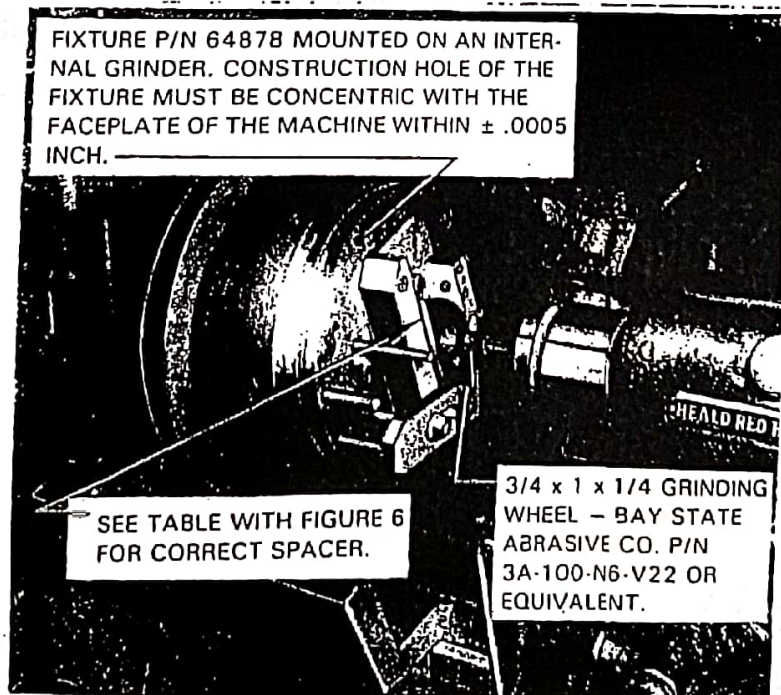
Figure 5. Counterweight and 64878 Fixture Assembled on an Internal Grinding Machine

The fixture P/N 64878 is sold without any mounting or locating holes drilled in its base. This allows the fixture to be mounted on any suitable machine without interference from pre-drilled holes.

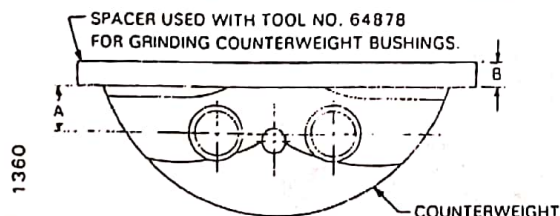
Figure 6. Identification of Dimension "A" and "B"

B. Select and install the correct spacer on the fixture and secure it to the alignment bar of the fixture with the three 1/4-20 socket head screws. The detail part number is stamped on the spacer. Refer to the table with Figure 6 for the correct spacer to use with each counterweight.

Counterweight Part No.	Spacer Detail Part No.	Dimensions		Weight (Lbs.) Minimum
		A	B $\pm .002$	
71904	12	.825	.425	1.796
LW-19225	27	.855	.395	1.796
71905	12	.825	.425	1.752
LW-19226	27	.855	.395	1.756
72801	10	.715	.535	1.846
LW-19227	28	.740	.510	1.846
72534	13	.950	.300	2.246
LW-19213	29	.965	.285	2.246
73643	15	.805	.445	2.212
LW-19211	12	.825	.425	2.212
73644	11	.741	.509	2.166
LW-19210	30	.761	.489	2.166
73812	16	.908	.342	2.266
LW-19212	31	.923	.327	2.266
74901	20	.720	.530	1.470
75636	20	.720	.530	1.600
75637	17	.875	.375	1.678
76044	18	.730	.520	1.810
78988	18	.730	.520	1.600

8. Counterweight Weight Limitations - A weight check is not necessary unless the counterweight has been ground to correct an improper balance condition. If the counterweight has been ground it must meet the minimum weight requirements shown in the table with Figure 6. Do not install any counterweight weighing less than the minimum weight, listed in the table, in any engine.

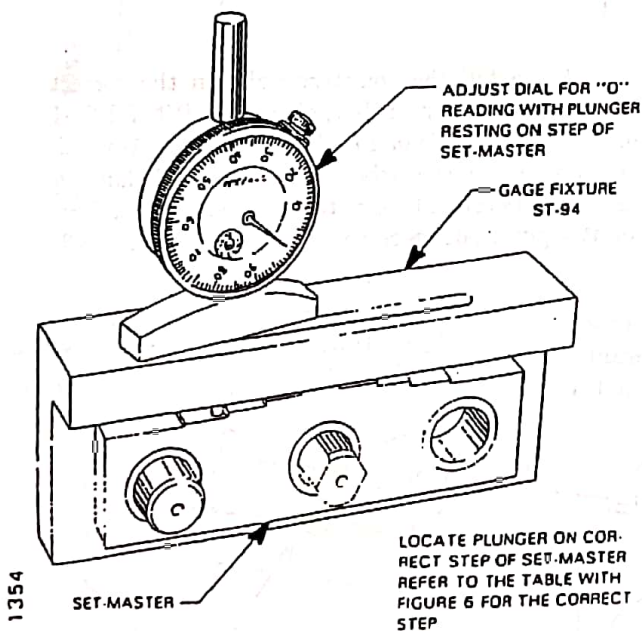
Figure 7. Depth Gage Adjusted with Set-Master Preparatory to Checking Line Position of Counterweight Bushings

B. Fixture P/N ST-94 is used to check the finished bushing bores for correct location. To set up the fixture, install the P/N ST-94-2 relieved locating pin in the center hole with the locating diameters in the vertical position as shown in Figure 7. Install the P/N ST-94-3 solid locating pin in the outside hole that has the same center to center distance as the counterweight bushing bores. The P/N ST-94-2 pin can remain permanently installed in the center hole with the P/N ST-94-3 being moved as required to adapt to the counterweight being inspected. If the pins do not fit into the newly ground bushing, it may be concluded that the bores are mislocated and the bushings must be replaced and reground again. If the counterweight fits, proceed to step C.

either P/N ST-94-5 or ST-94-10 set-master in the following manner. Place the set-master over the locating pins of the fixture (refer to Figure 7), preload the depth gage approximately .010 inch, set the dial gage to "0" with the plunger resting on the appropriate step of the set-master. The steps are identified by the "A" dimensions from the table with Figure 6. Remove the set-master and install the counterweight over the pins. Set the depth indicator thru the fixture and onto the counterweight. Refer to Figure 8. No more than  $\pm .004$  inch difference between this measurement and the measurement obtained with the set-master is allowed.

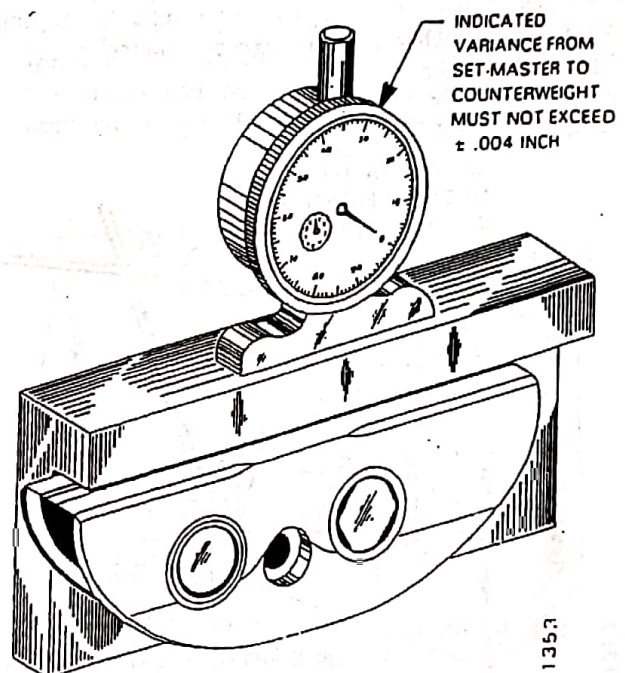
Figure 8. Checking Center Line Position of Counterweight Using Gage Fixture ST-94

C. Also check the distance from the center of the bushing bore to the flat edge of the counterweight with the fixture P/N ST-94 and

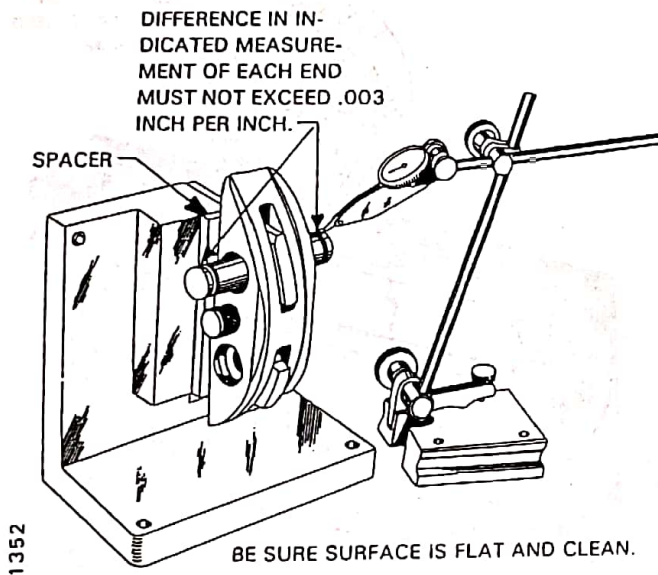
Figure 9. Checking Parallel and Squareness of Counterweight Bushings with Gage Fixture ST-91 - Vertical Position

During the following step (D) if erratic or excessively "out of limits" measurements are observed, remove the counterweight and insert it on the P/N ST-91 fixture so that the opposite inner face of the counterweight is located against the fixture. Then repeat the measurements. Only one of the inner faces of the counterweight is square with the bushing bores.

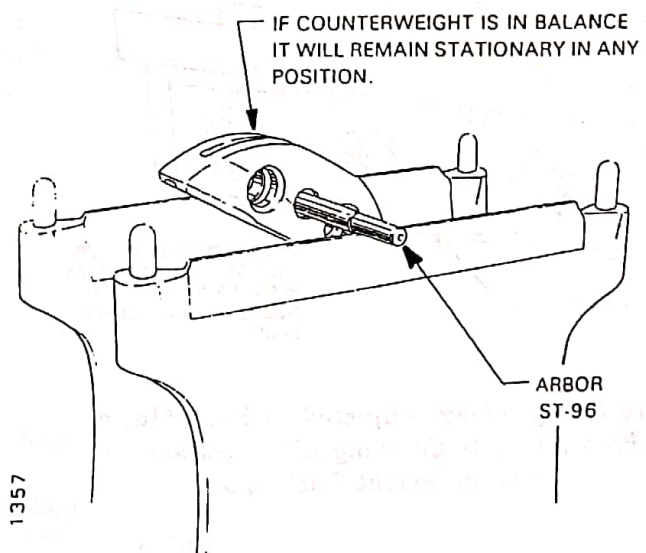
Figure 11. Counterweight Mounted on ST-96 Arbor for Balancing

A. Install the counterweight on the correct P/N ST-96 balancing arbor, either the P/N ST-96-1 for the 3/8 inch hole or P/N ST-96-2 for the 1/4 inch hole, and place the arbor on a pair of balancing ways. Insure each blade of the ways engages the arbor at a point not more than 1-1/2" from each end.

The center of both of the P/N ST-96 arbors is tapered to compensate for slight variations in the diameter of the hole. The first 1-1/2 inches of each end of the arbor is carefully ground to insure concentric diameters.

B. If the counterweight is in perfect balance it will remain in any position it is placed. See Figure 11. If it has a tendency to move, try to keep it in

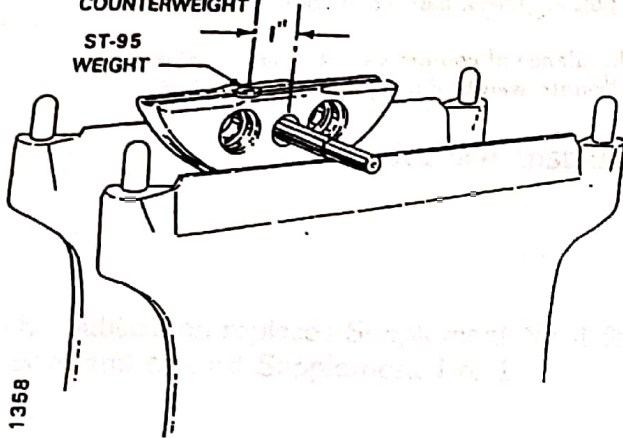
Figure 12. Counterweight Balanced by Weight ST-95 Placed Within One Inch from Center

BALANCE MUST BE ACHIEVED BY PLACING WEIGHT NOT MORE THAN 1 INCH FROM CENTER OF COUNTERWEIGHT

balance by placing the center of the P/N ST-95 weight not more than 1" from the center of the arbor. See Figure 12. If the counterweight can be brought into balance with the addition of this weight the balance can be considered satisfactory.

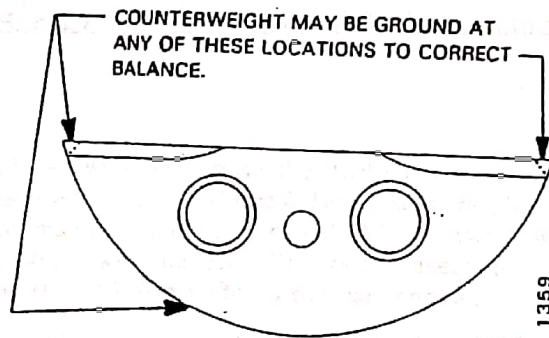
Figure 13. Location of Areas on Counterweight for Grinding

C. If the counterweight cannot be brought into balance by the addition of the P/N ST-95 weight, carefully grind the heavy end at the locations shown in Figure 13.

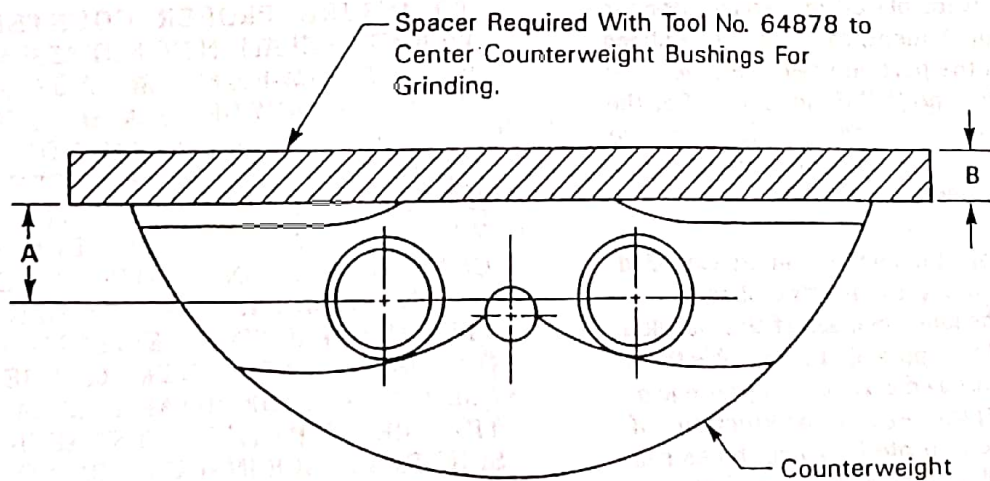
Figure 6. (Revised) Identification of Dimension "A" and "B"

Counterweight Part No.	Spacer Detail Part No.	Dimensions		Weight (Lbs.) Minimum
		A	B ± .002	
71904	12	.825	.425	1.796
LW-19225D	27	.855	.395	1.796
LW-19225E	17	.875	.375	1.796
71905	12	.825	.425	1.752
LW-19226D	27	.855	.395	1.756
LW-19226E	17	.875	.375	1.756
72801	10	.715	.535	1.846
LW-19227D	28	.740	.510	1.846
LW-19227E*	30	.760	.490	1.846
72534	13	.950	.300	2.246
LW-19213	29	.965	.285	2.246
73643	15	.805	.445	2.212
LW-19211	12	.825	.425	2.212
73644	11	.741	.509	2.166
LW-19210	30	.761	.489	2.166
73812	16	.908	.342	2.266
LW-19212	31	.923	.327	2.266
74901	20	.720	.530	1.470
75636	20	.720	.530	1.600
75637	17	.875	.375	1.678
76044	18	.730	.520	1.810
78988	18	.730	.520	1.600

\* Use spacer No. 30 and .001 inch thick shim stock to achieve .490 spacer thickness when grinding the bushings in a P/N LW-19227E counterweight.

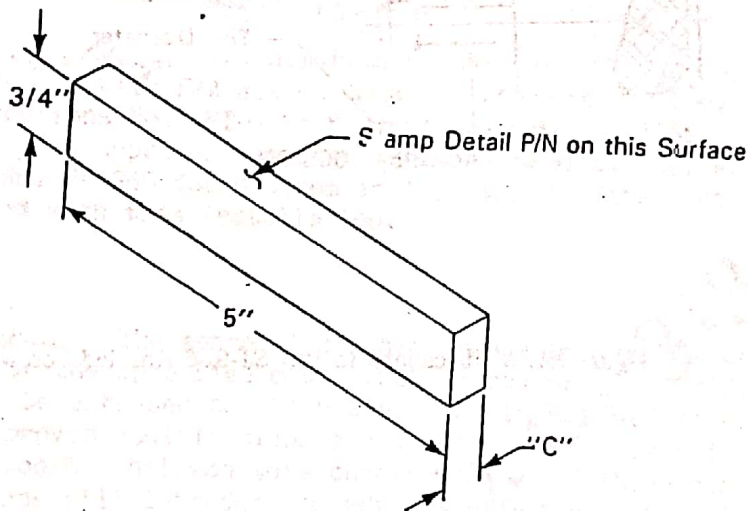
Figure 3. (Revised) Dimensions of New Spacers for ST-91 Gage

3. Figure 3 is revised and included with this Supplement, to show spacer application for the revised counterweights. Figure 3A is added to illustrate an undercut to the P/N ST-91-6 knurled screw. This undercut is required to allow use of existing spacers with the revised counterweights.

73643, 73644, 72534, 73812  
72801, LW-19225E, LW-19226E  
71904, 71905, LW-19210  
LW-19225D, LW-19226D, 75637  
LW-19227D  
LW-19211, LW-19227E  
LW-19212  
75636, 76044, 78988

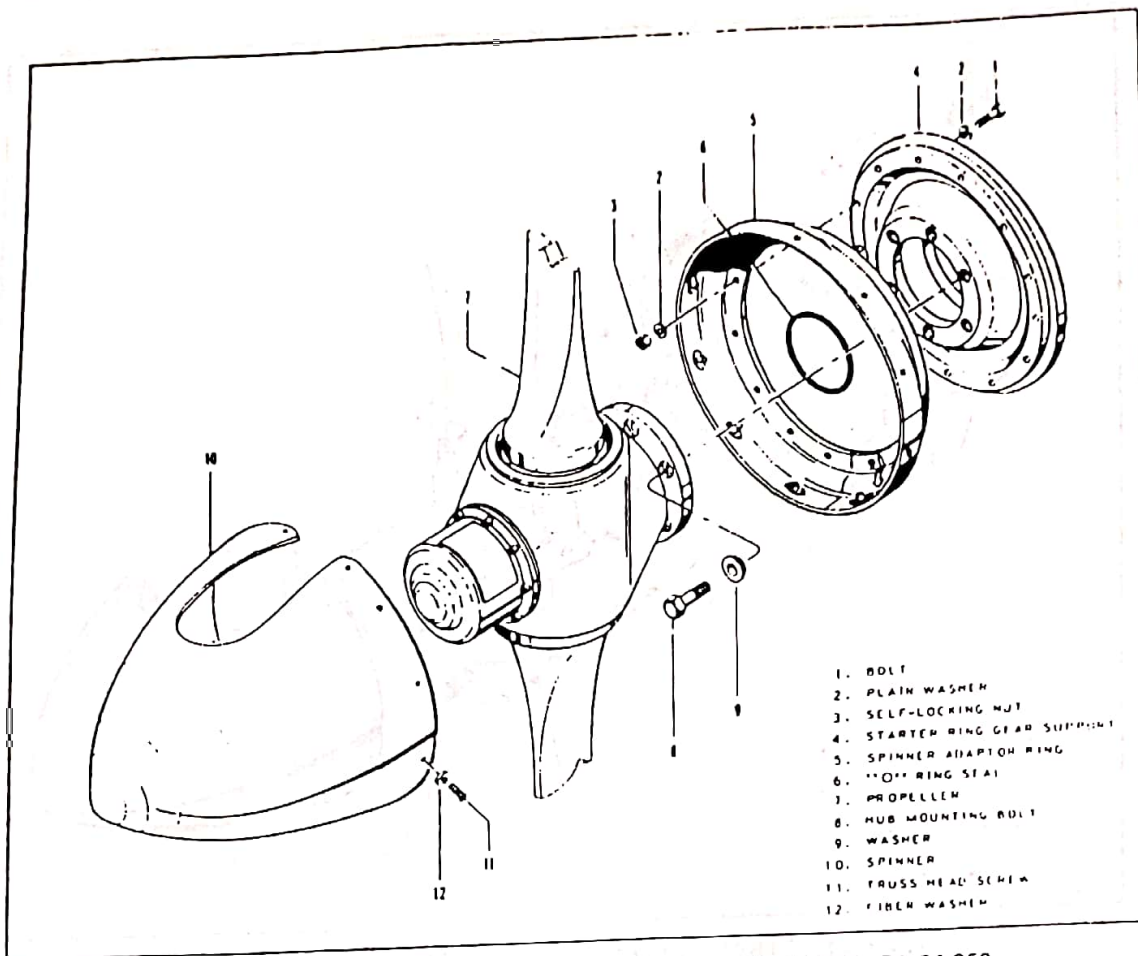
FIGURE A-1. PROPELLER INSTALLATION (MCCAULEY) PA-24-250

A-1 Removal Of Propeller. (McCauley) (PA-24-250) (Refer to Figure A-1)

- a. Remove the spinner (10) by removing the screws (11) that secure it to the spinner bulkhead (5)
- b. Place a drip pan under the propeller to catch oil spillage
- c. Cut the safety wire around the propeller mounting bolts (8) and remove the bolts from the engine crankshaft flange
- d. Pull the propeller from the engine crankshaft
- e. Remove the propeller "O" ring (6) from the propeller hub bore
- f. The spinner bulkhead (5) may be removed from the starter ring gear (4) by removing nuts, washers and bolts.

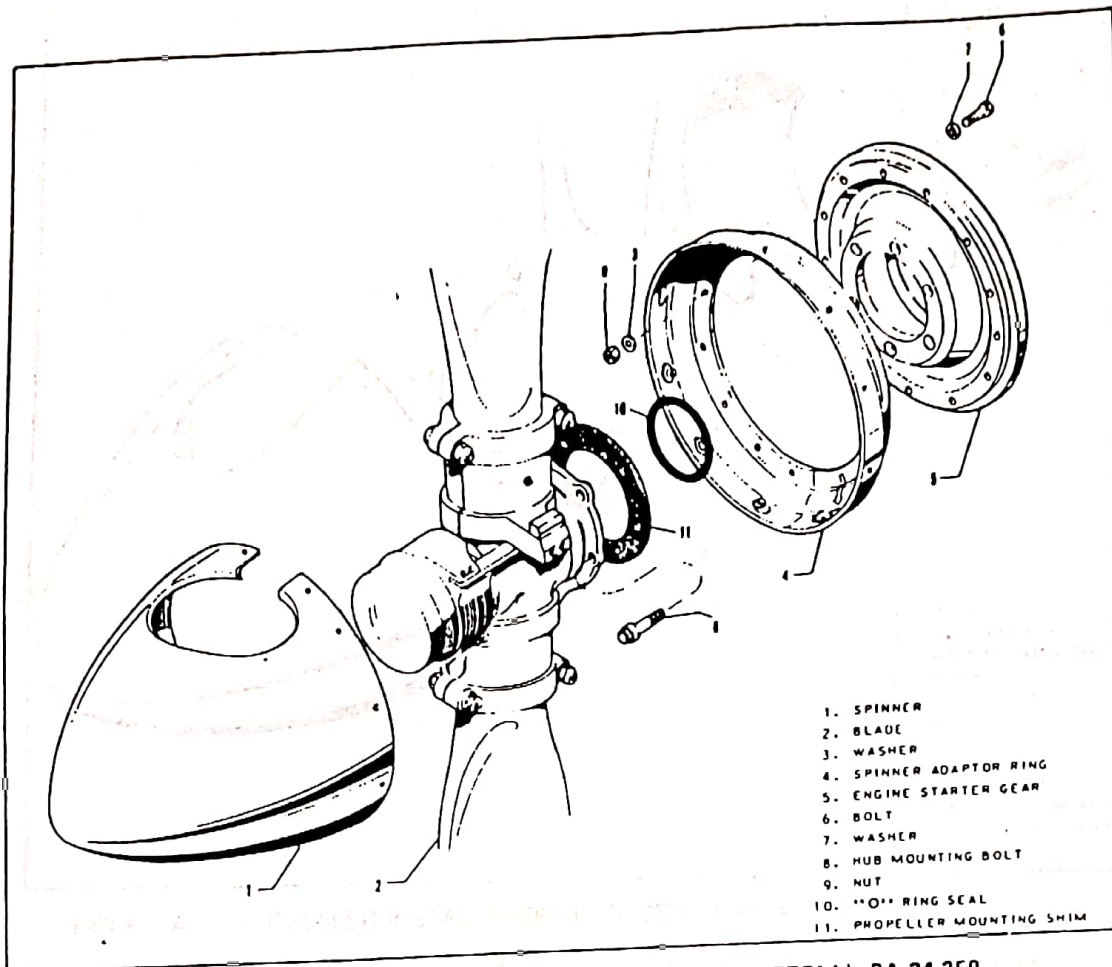
**FIGURE A-2. PROPELLER INSTALLATION (HARTZELL) PA-24-250**

**A-2 Removal Of Propeller. (Hartzell) (PA-24-250) (Refer to Figure A-2.)**

- a. Ascertain that the master switch and magneto switches are in the OFF position.
- b. Remove the spinner (1) by removing the screws that secure it to the spinner bulkhead (4).
- c. Place a drip pan under the propeller to catch oil spillage
- d. Cut the safety wire around the propeller mounting bolts (8) and remove them from the engine crankshaft flange.
- e. Pull the propeller from the engine crankshaft.
- f. Remove the propeller "O" ring (10) and shim (11) from the engine flange
- g. The spinner bulkhead (4) may be removed from the starter ring gear (8) by removing nuts, washers and bolts

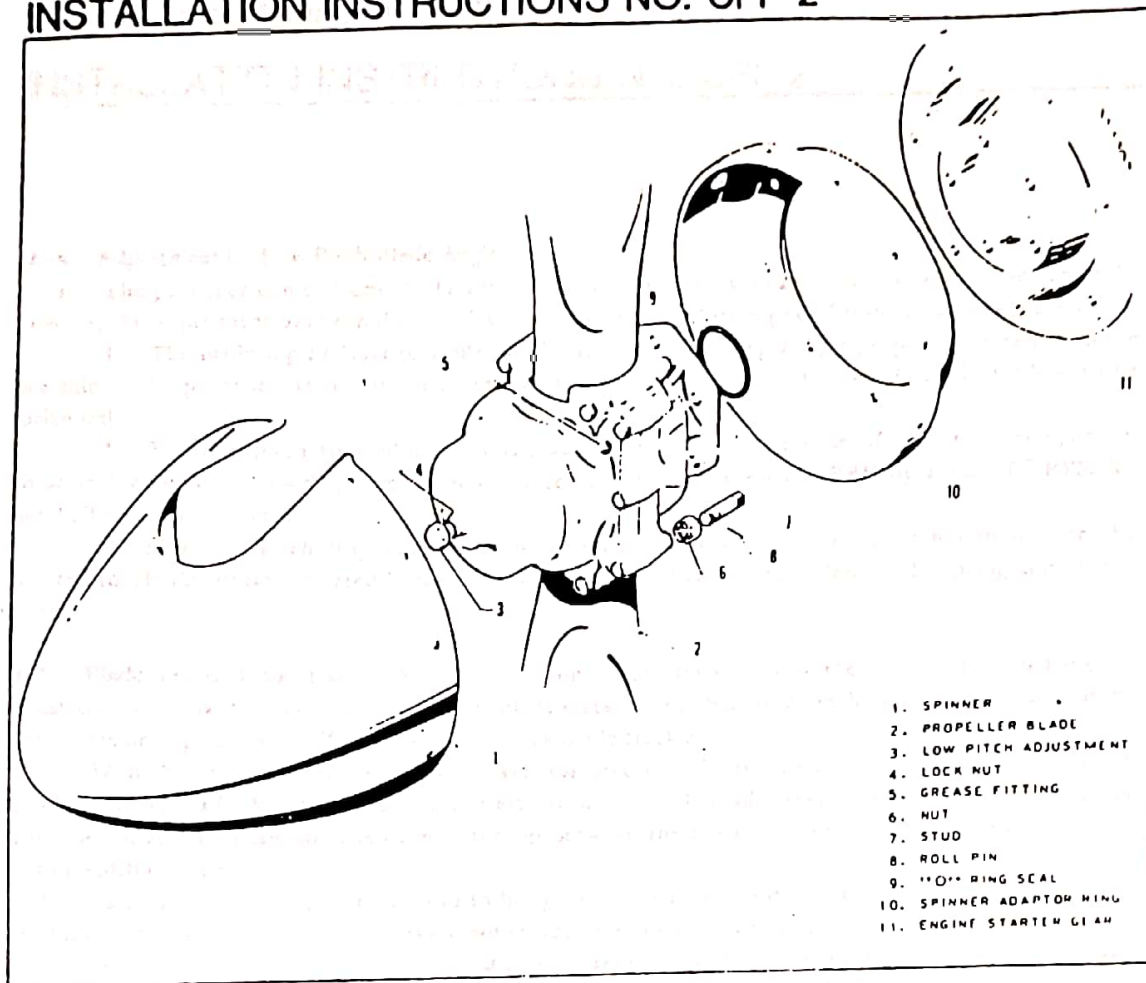
FIGURE A-3. PROPELLER INSTALLATION (HARTZELL) PA-24-250 (MODIFIED)

A-3. Installation Of Propeller, Hartzell Model HC-C2YK-1BF/8477D-5R and Hartzell Spinner Assembly, Part No. 82-A3519 (Refer to Figure A-3)

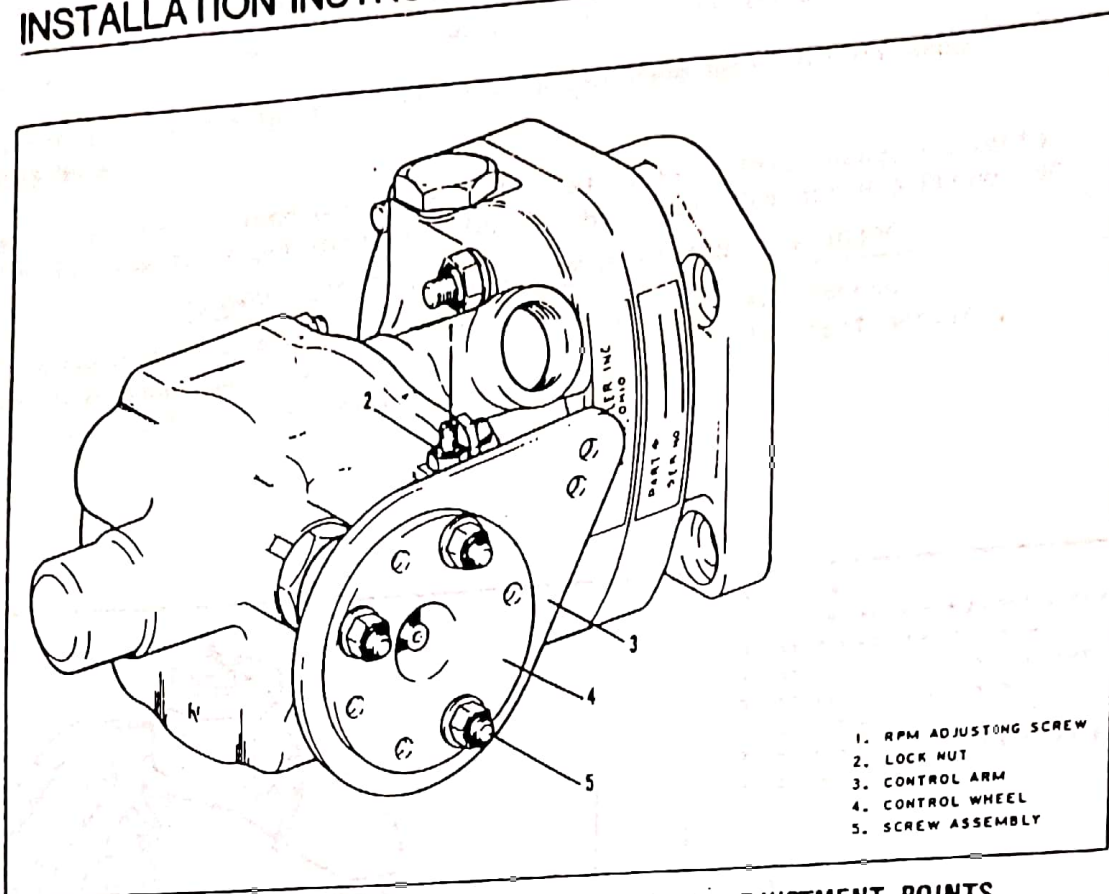
FIGURE A-5. HARTZELL PROPELLER GOVERNOR ADJUSTMENT POINTS

A-10. Adjustment Of Propeller Governor. (Hartzell) (Refer to Figure A-5.)

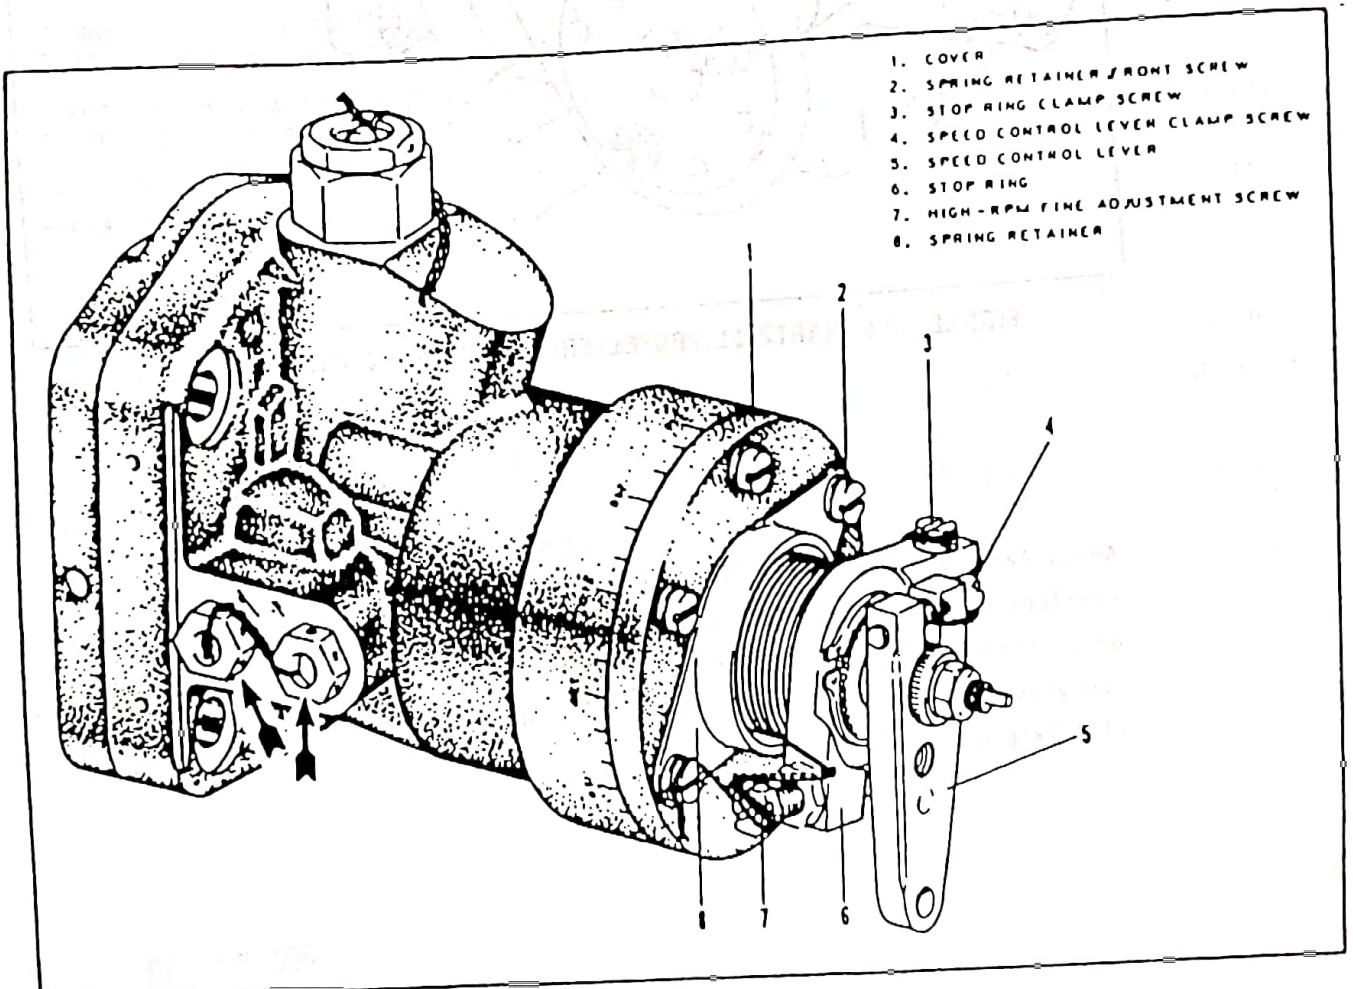
WOODWARD PROPELLER GOVERNOR

WOODWARD 210305 GOVERNOR MODIFICATION TO A210305

This Modification MUST be accomplished by a qualified Governor Overhaul Shop due to Pilot Valve change. Johnston Aircraft Service, Inc. can furnish a re-worked Exchange Governor.

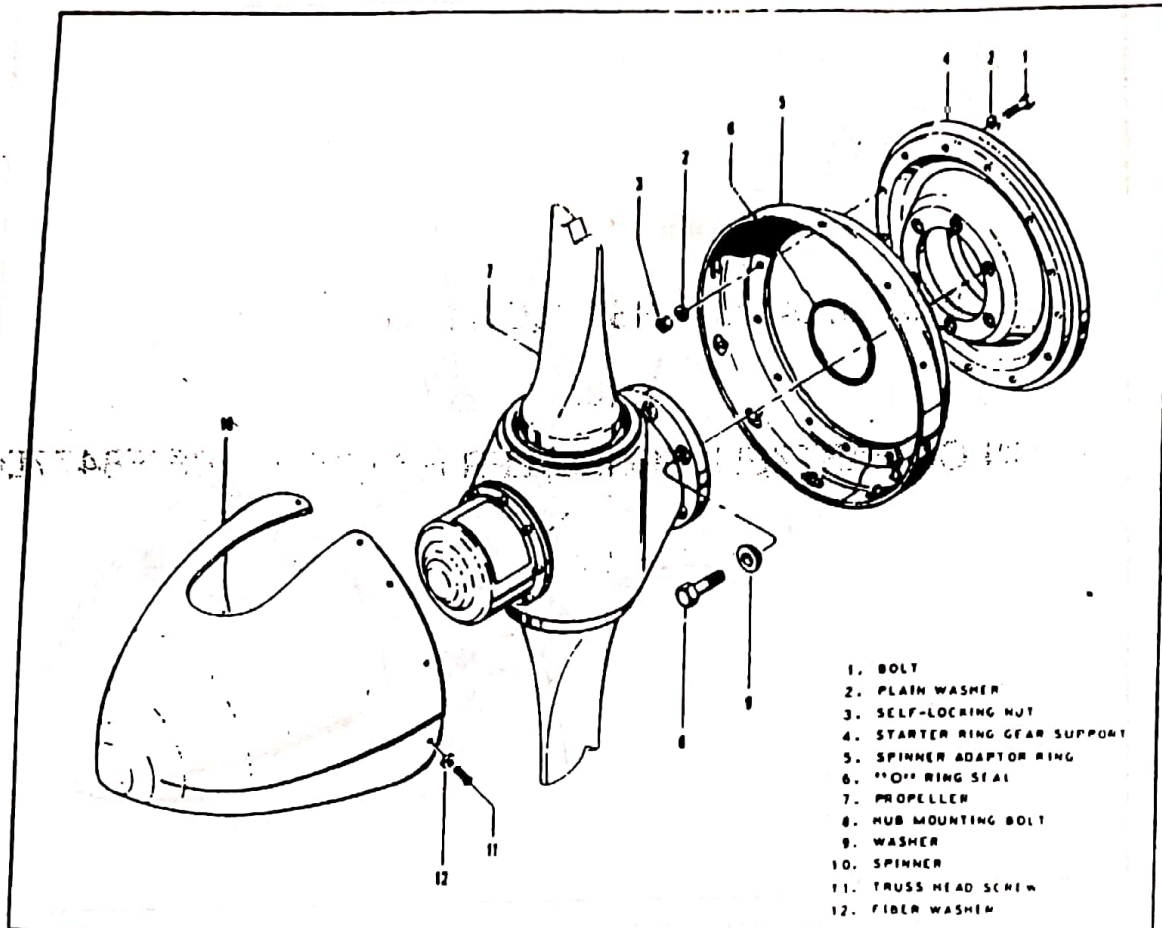
**FIGURE A-1. PROPELLER INSTALLATION (MCCAULEY) PA-24-250**

**A-1 Removal Of Propeller. (McCauley) (PA-24-250) (Refer to Figure A-1.)**

- a. Remove the spinner (10) by removing the screws (11) that secure it to the spinner bulkhead (5)
- b. Place a drip pan under the propeller to catch oil spillage
- c. Cut the safety wire around the propeller mounting bolts (8) and remove the bolts from the engine crankshaft flange
- d. Pull the propeller from the engine crankshaft.
- e. Remove the propeller "O" ring (6) from the propeller hub bore
- f. The spinner bulkhead (5) may be removed from the starter ring gear (4) by removing nuts, washers and bolts.

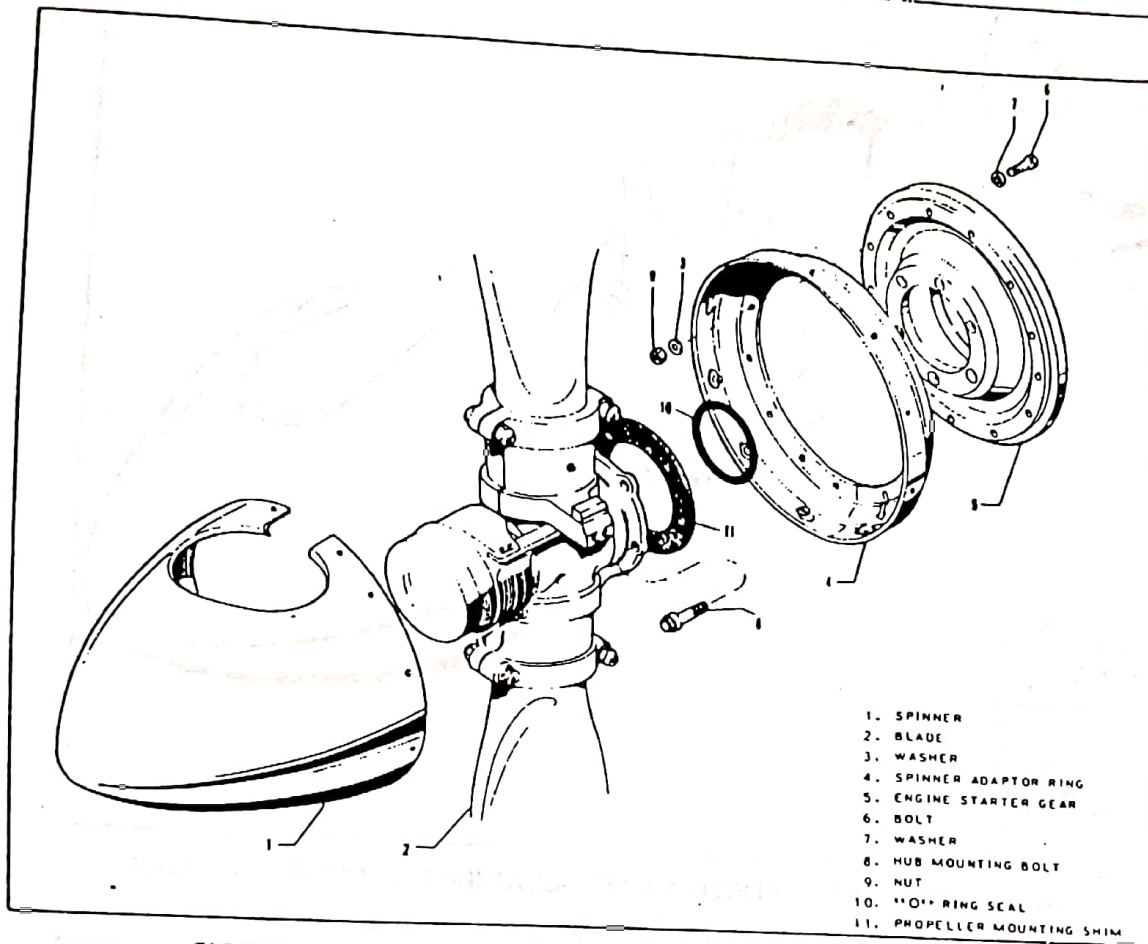
FIGURE A-2. PROPELLER INSTALLATION (HARTZELL) PA-24-250

A-2 Removal Of Propeller. (Hartzell) (PA-24-250) (Refer to Figure A-2.)

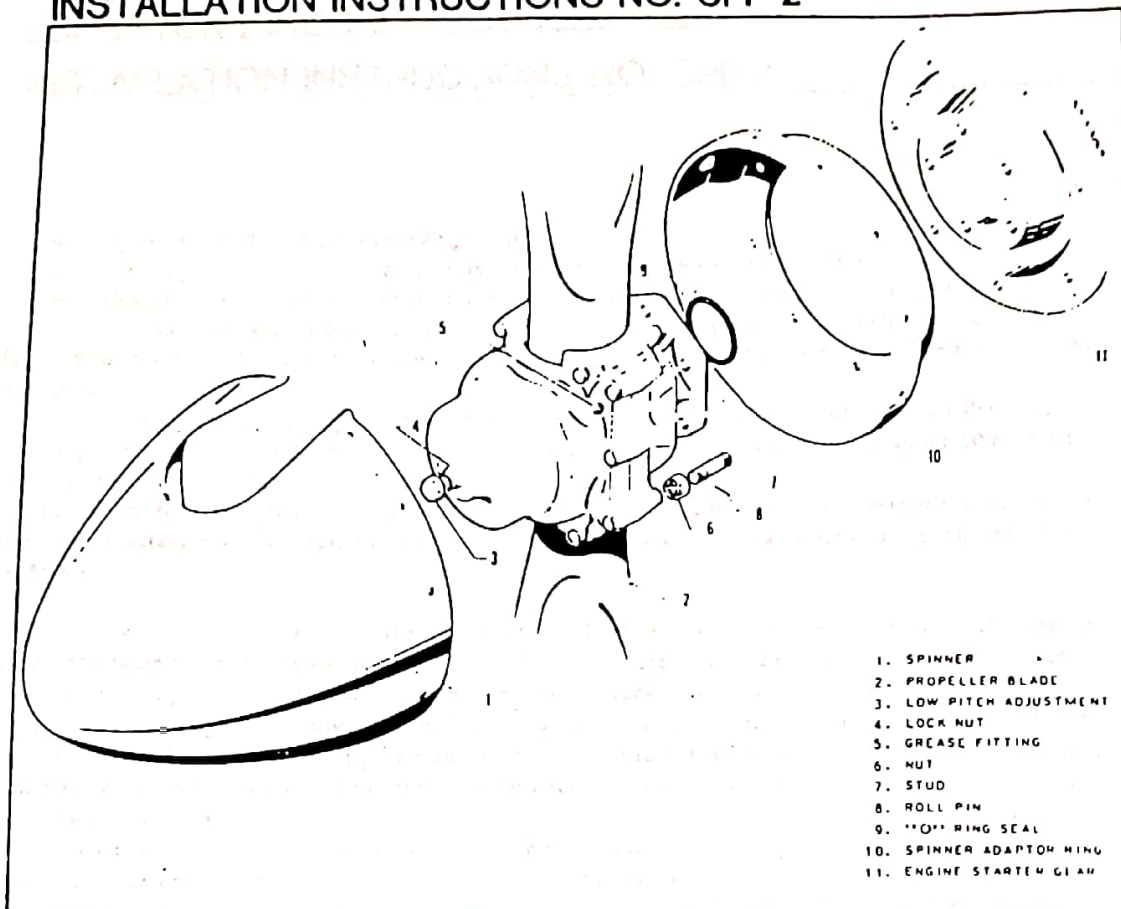
FIGURE A-3. PROPELLER INSTALLATION (HARTZELL) PA-24-250 (MODIFIED)

A-3. Installation Of Propeller, Hartzell Model HC-C2YK-1BF/8477D-5R and Hartzell Spinner Assembly, Part No. 82-A3519 (Refer to Figure A-3)

- a. Ascertain that the master switch and magneto switches are in the OFF position.
- b. Remove the spinner (1) by removing the screws that secure it to the spinner bulkhead (4).
- c. Place a drip pan under the propeller to catch oil spillage
- d. Cut the safety wire around the propeller mounting bolts (8) and remove them from the engine crankshaft flange.
- e. Pull the propeller from the engine crankshaft.
- f. Remove the propeller "O" ring (10) and shim (11) from the engine flange
- g. The spinner bulkhead (4) may be removed from the starter ring gear (8) by removing nuts, washers and bolts.

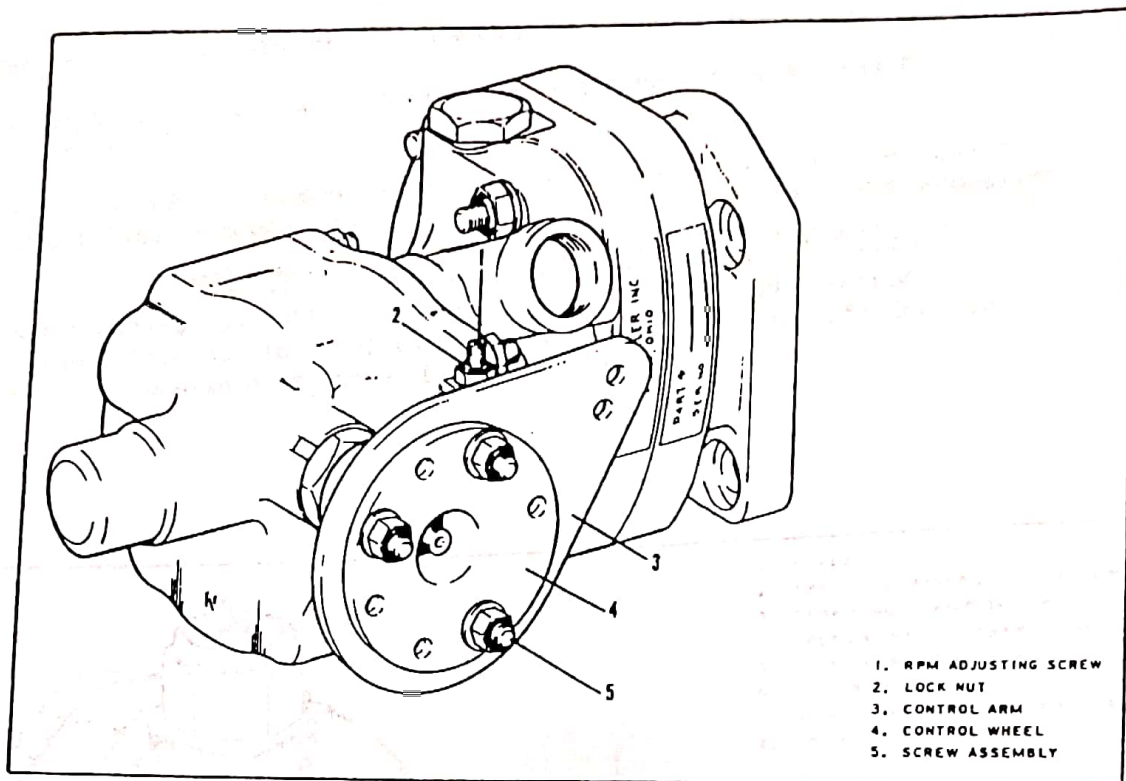
FIGURE A-5. HARTZELL PROPELLER GOVERNOR ADJUSTMENT POINTS

A-10. Adjustment Of Propeller Governor. (Hartzell) (Refer to Figure A-5.)

- d. Observe engine speed. Adjust the governor by means of the fine adjustment screw for 2575 RPM. To do this, loosen the fine adjustment screw locknut and turn the hi-rpm fine adjustment screw in a clockwise direction to decrease engine speed and a counterclockwise rotation to increase engine speed. One revolution of the fine adjustment screw increases or decreases the propeller speed approximately 15 RPM.

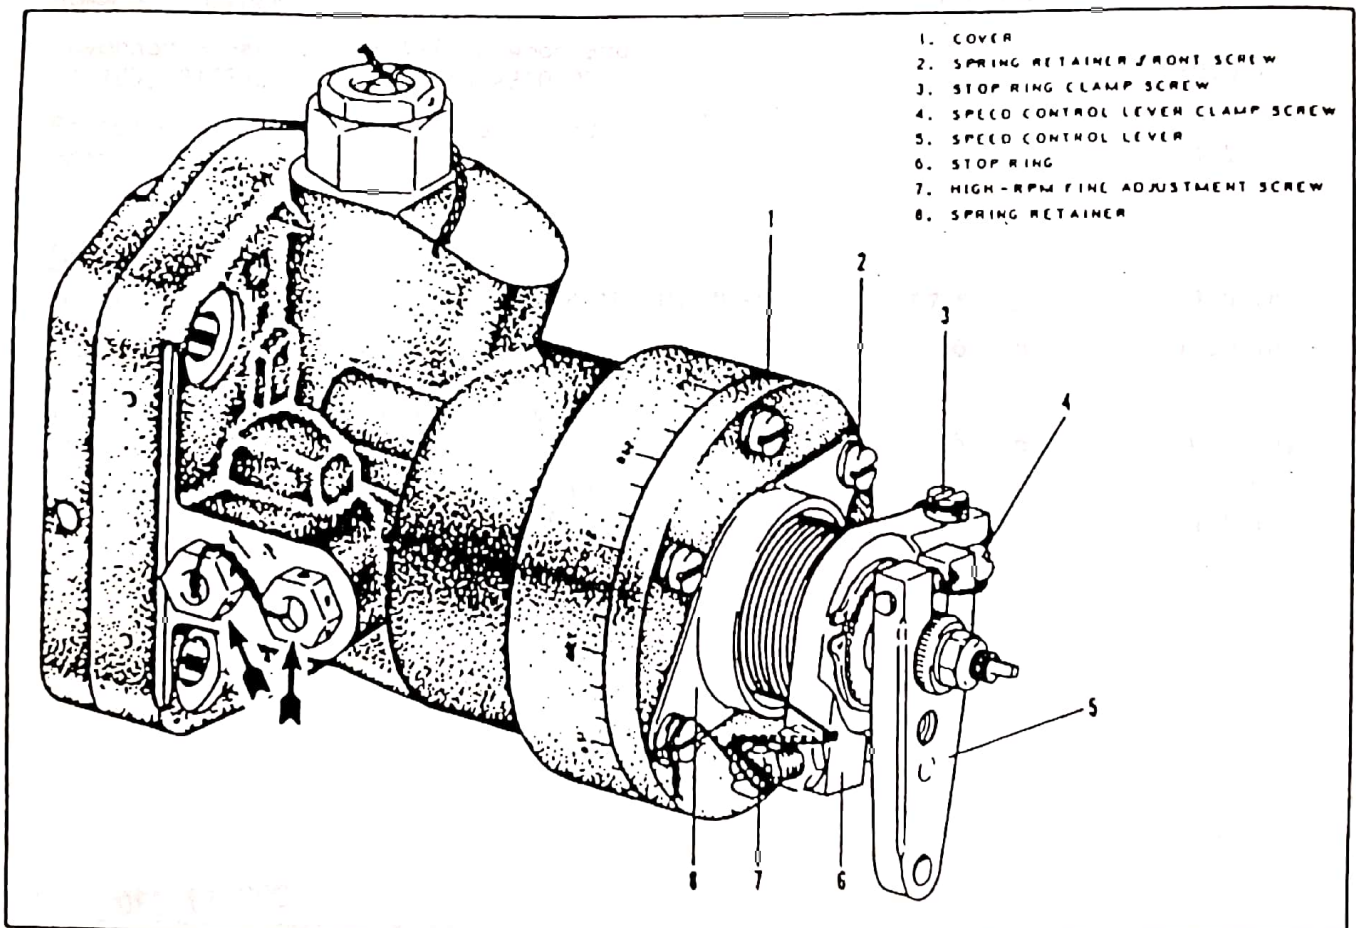
WOODWARD PROPELLER GOVERNOR

WOODWARD 210305 GOVERNOR MODIFICATION TO A210305

This Modification MUST be accomplished by a qualified Governor Overhaul Shop due to Pilot Valve change. Johnston Aircraft Service, Inc. can furnish a re-worked Exchange Governor.
